General Information

Make	Toyota	Model	Vios
YOM	2023	Odo Meter Reading	1,496
Registration No.	DBI1811	Chassis No.	PA1B18F31P4214525
CC	1.3	Transmission	CVT
Fuel Type	Gas	Type of Body	Sedan
Colour	Silver

Body / Panel Condition

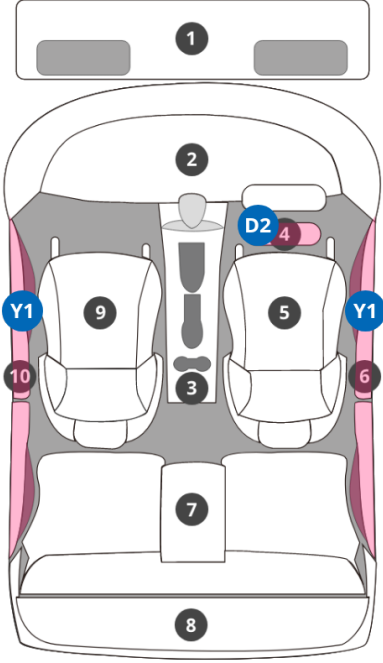
Interior Evaluation : A	Exterior Evaluation : C

<p>a : Cut, Fray d : Loose, Deformed k : Animal Hair s : Smell t : Cigarette Burns x : Defective y : Stain</p>

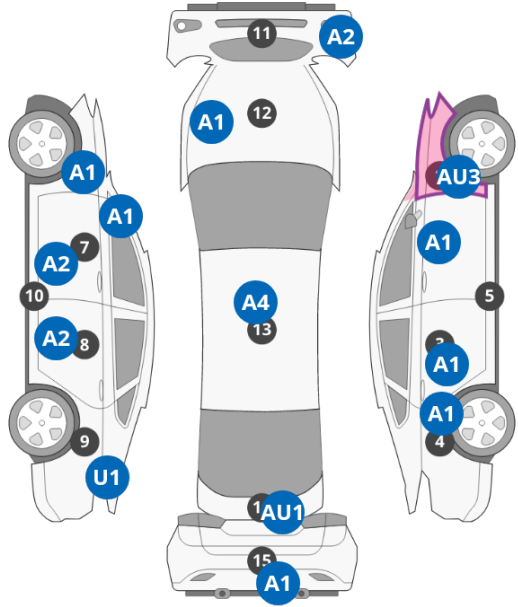
<p>A : Scratch AU : Scratch & Dent B : Modified C : Corrosion G : Stone chip P : Faded S : Rust SC : Rust & Corrosion U : Dent X : Defective Y : Crack, Gap</p>
<p>Remarks (L) Front Floor Mat - Worked - Small / (L) Front Trim - Grime - Minimal / (R) Front Trim - Grime - Minimal</p>	<p>Remarks (R) Front Fender, Molding - Repair mark - Yes / (R) Front Fender, Molding - Scratch & Dent - Medium / (R) Front Door, Molding - Scratch - Minimal / (R) Rear Door, Molding - Scratch - Minimal / (R) Rear Fender, Molding - Scratch - Minimal / Rear Bumper, Lamps, Panels - Scratch - Minimal / Trunk Hood, Rear Gate - Scratch & Dent - Minimal / (L) Rear Door, Molding - Scratch - Small / (L) Front Door, Molding - Scratch - Small / (L) Mirror - Scratch - Minimal / (L) Front Fender, Molding - Scratch - Minimal / Front Bumper, Grille, Lamps - Scratch - Small / Bonnet, Headlight - Scratch - Minimal / Roof - Scratch - Large / (L) Rear Fender, Molding - Dent - Minimal</p>
