## General Information

<b>Make</b>	Toyota	<b>Model</b>	Wigo
<b>YOM</b>	2025	<b>Odo Meter Reading</b>	6,654
<b>Registration No.</b>	DCA7667	<b>Chassis No.</b>	MHKAA1BC3SJ041806
<b>CC</b>	1.0	<b>Transmission</b>	CVT
<b>Fuel Type</b>	Gas	<b>Type of Body</b>	Sedan
<b>Colour</b>	Red

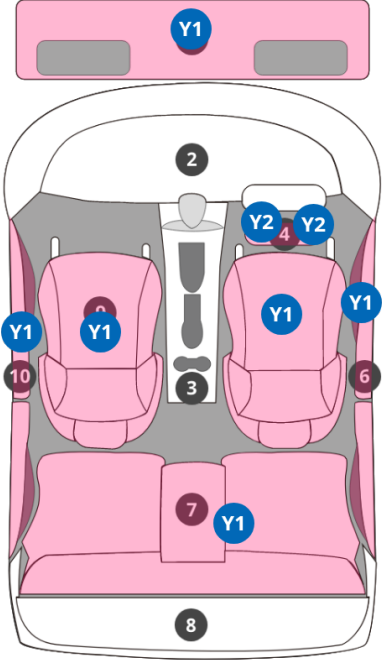
<b>Interior Evaluation :</b> <span style="float: right; color: red; font-weight: bold;">A</span>	<b>Exterior Evaluation :</b> <span style="float: right; color: red; font-weight: bold;">C</span>

<p><b>a</b> : Cut, Fray <b>d</b> : Loose, Deformed <b>k</b> : Animal Hair <b>s</b> : Smell <b>t</b> : Cigarette Burns <b>x</b> : Defective <b>y</b> : Stain</p>

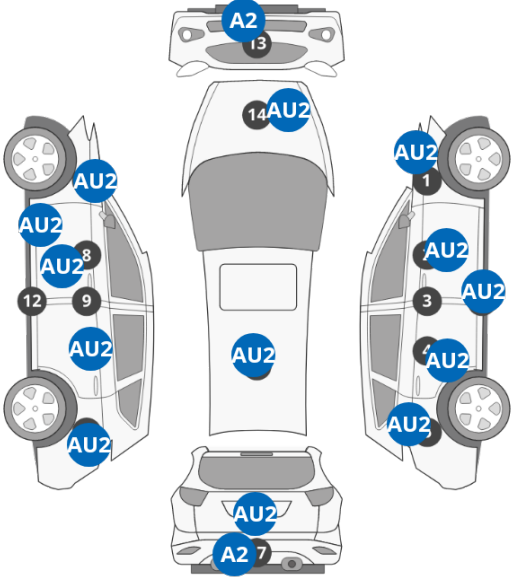
<p><b>A</b> : Scratch <b>AU</b> : Scratch &amp; Dent <b>B</b> : Modified <b>C</b> : Corrosion <b>G</b> : Stone chip <b>P</b> : Faded <b>S</b> : Rust <b>SC</b> : Rust &amp; Corrosion <b>U</b> : Dent <b>X</b> : Defective <b>Y</b> : Crack, Gap</p>
<p><b>Remarks</b> Ceiling - Grime - Minimal / (R) Front Seat - Grime - Minimal / (L) Front Seat - Grime - Minimal / (L) Front Trim - Grime - Minimal / (R) Front Trim - Grime - Minimal / Rear Seat - Grime - Minimal / (L) Front Floor Mat - Grime - Small / (R) Front Floor Mat - Grime - Small</p>	<p><b>Remarks</b> Trunk Hood, Rear Gate - Scratch &amp; Dent - Small / Rear Bumper, Lamps, Panels - Scratch - Small / (R) Rear Fender, Molding - Scratch &amp; Dent - Small / (R) Rear Door, Molding - Scratch &amp; Dent - Small / (R) Front Door, Molding - Scratch &amp; Dent - Small / (R) Step, In-panel, Side Spoiler - Scratch &amp; Dent - Small / (R) Front Fender, Molding - Scratch &amp; Dent - Small / Bonnet, Headlight - Scratch &amp; Dent - Small / (L) Front Fender, Molding - Scratch &amp; Dent - Small / Roof - Scratch &amp; Dent - Small / (L) Rear Door, Molding - Scratch &amp; Dent - Small / (L) Front Door, Molding - Scratch &amp; Dent - Small / (L) Step, In-panel, Side Spoiler - Scratch &amp; Dent - Small / (L) Rear Fender, Molding - Scratch &amp; Dent - Small / Front Bumper, Grille, Lamps - Scratch - Small</p>

<p><b>Inspector Notes</b></p>
<p>with LTO plate, with manual booklet, with reverse camera, with spare tire, with spare key, scratches on taillight and headlight.</p>
