## General Information

<b>Make</b>	Toyota	<b>Model</b>	Wigo
<b>YOM</b>	2023	<b>Odo Meter Reading</b>	28,935
<b>Registration No.</b>	NFO2070	<b>Chassis No.</b>	MHKA4DF5FNJ072569
<b>CC</b>	1.0	<b>Transmission</b>	A/T
<b>Fuel Type</b>	Gas	<b>Type of Body</b>	Hatchback
<b>Colour</b>	Gray

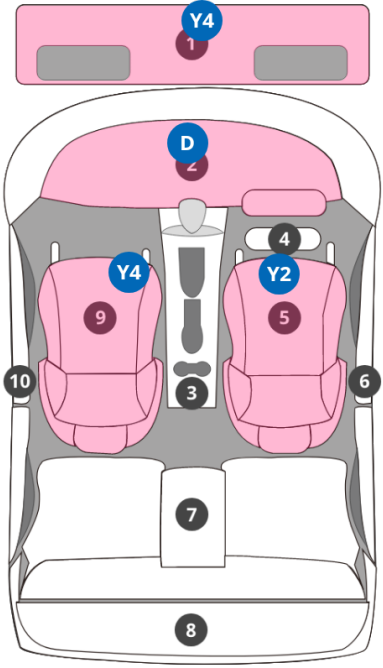
<b>Interior Evaluation :</b> <span style="float: right; color: red; font-weight: bold;">C</span>	<b>Exterior Evaluation :</b> <span style="float: right; color: red; font-weight: bold;">E</span>

<p><b>a</b> : Cut, Fray <b>d</b> : Loose, Deformed <b>k</b> : Animal Hair <b>s</b> : Smell <b>t</b> : Cigarette Burns <b>x</b> : Defective <b>y</b> : Stain</p>

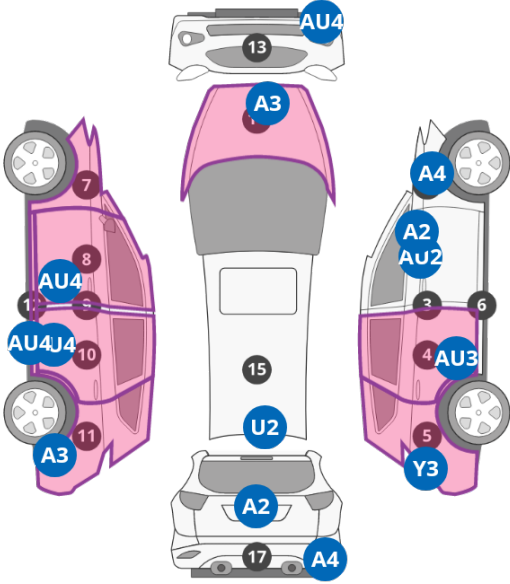
<p><b>A</b> : Scratch <b>AU</b> : Scratch &amp; Dent <b>B</b> : Modified <b>C</b> : Corrosion <b>G</b> : Stone chip <b>P</b> : Faded <b>S</b> : Rust <b>SC</b> : Rust &amp; Corrosion <b>U</b> : Dent <b>X</b> : Defective <b>Y</b> : Crack, Gap</p>
<p><b>Remarks</b> Ceiling - Grime - Large / (R) Front Seat - Grime - Small / (L) Front Seat - Grime - Large / Dashboard - Traces of Adhesive Tape - Yes</p>	<p><b>Remarks</b> (R) Front Door - Repair Traces - Yes / Bonnet - Repair Traces - Yes / (L) Front Fender - Repair Traces - Yes / (L) Front Door - Repair Traces - Yes / (L) Step - Repair Traces - Yes / (L) Rear Door - Repair Traces - Yes / (R) Rear Door - Repair Traces - Yes / (R) Rear Door, Molding - Scratch &amp; Dent - Medium / (R) Rear Door, Molding - Repair mark - Yes / (R) Rear Fender, Molding - Repair mark - Yes / (R) Front Fender, Molding - Scratch - Large / Front Bumper, Grille, Lamps - Scratch &amp; Dent - Large / Bonnet, Headlight - Repair mark - Yes / Bonnet, Headlight - Scratch - Medium / (L) Front Fender, Molding - Repair mark - Yes / (L) Front Fender, Molding - Crack, Gap - Large / (L) Front Door, Molding - Repair mark - Yes / (L) Front Door, Molding - Scratch &amp; Dent - Large / (L) Step, In-panel, Side Spoiler - Repair mark - Yes / (L) Rear Door, Molding - Repair mark - Yes / (L) Rear Door, Molding - Scratch &amp; Dent - Large / (L) Step, In-panel, Side Spoiler - Scratch &amp; Dent - Large / (L) Rear Fender, Molding - Repair mark - Yes / (L) Rear Fender, Molding - Scratch - Medium / Rear Bumper, Lamps, Panels - Scratch - Large / (R) Rear Fender, Molding - Crack, Gap - Medium / (R) Front Door, Molding - Scratch &amp; Dent - Small / (R) Mirror - Scratch - Small / Roof Spoiler, Molding - Dent - Small / Trunk Hood, Rear Gate - Scratch - Small</p>
