General Information

Make	Toyota	Model	Vios
YOM	2024	Odo Meter Reading	66,259
Registration No.	NKA1468	Chassis No.	PA1B18F3XR4241838
CC	1.3	Transmission	CVT
Fuel Type	Gas	Type of Body	Sedan
Colour	Red Mica Metallic

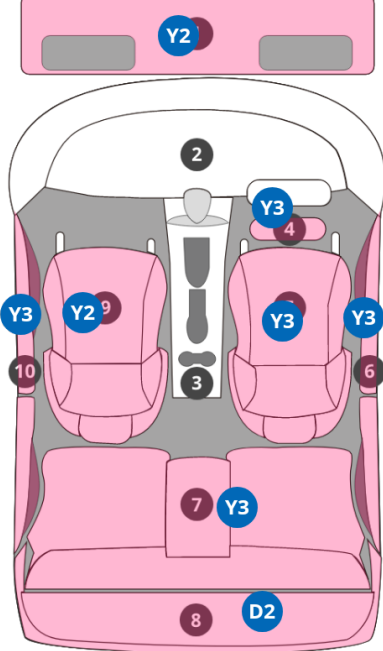
Interior Evaluation : C	Exterior Evaluation : E

<p>a : Cut, Fray d : Loose, Deformed k : Animal Hair s : Smell t : Cigarette Burns x : Defective y : Stain</p>

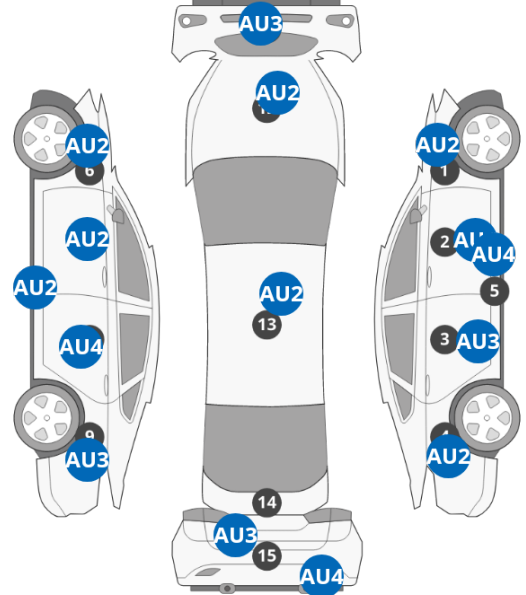
<p>A : Scratch AU : Scratch & Dent B : Modified C : Corrosion G : Stone chip P : Faded S : Rust SC : Rust & Corrosion U : Dent X : Defective Y : Crack, Gap</p>
<p>Remarks (L) Front Floor Mat - Grime - Medium / (L) Front Seat - Grime - Small / (R) Front Seat - Grime - Medium / Rear Seat - Grime - Medium / (L) Front Trim - Grime - Medium / (R) Front Trim - Grime - Medium / Ceiling - Grime - Small / Trunk Room - Loose, Deformed - Small</p>	<p>Remarks (R) Step - Repair Traces - Yes / (R) Front Fender - Repair Traces - Yes / (L) Front Fender - Repair Traces - Yes / (L) Rear Door, Molding - Scratch & Dent - Large / Roof - Scratch & Dent - Small / (L) Front Door, Molding - Scratch & Dent - Small / (L) Step, In-panel, Side Spoiler - Scratch & Dent - Small / (L) Front Fender, Molding - Scratch & Dent - Small / Bonnet, Headlight - Scratch & Dent - Small / Front Bumper, Grille, Lamps - Scratch & Dent - Medium / (R) Front Fender, Molding - Scratch & Dent - Small / (R) Front Door, Molding - Scratch & Dent - Large / (R) Step, In-panel, Side Spoiler - Scratch & Dent - Large / (R) Rear Door, Molding - Scratch & Dent - Medium / (R) Rear Fender, Molding - Scratch & Dent - Small / (L) Rear Fender, Molding - Scratch & Dent - Medium / Trunk Hood, Rear Gate - Scratch & Dent - Medium / Rear Bumper, Lamps, Panels - Scratch & Dent - Large</p>
