General Information

Make	Toyota	Model	Vios
YOM	2025	Odo Meter Reading	12,941
Registration No.	NKL4787	Chassis No.	PA1B18F33R4260810
CC	1.3	Transmission	CVT
Fuel Type	Gas	Type of Body	Sedan
Colour	Red Mica Metallic

Body / Panel Condition

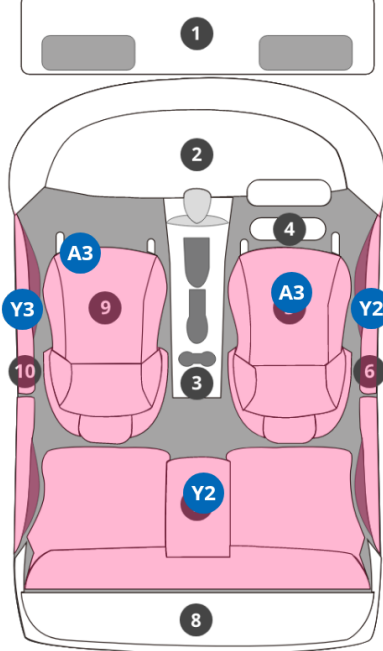
Interior Evaluation : B	Exterior Evaluation : D

<p>a : Cut, Fray d : Loose, Deformed k : Animal Hair s : Smell t : Cigarette Burns x : Defective y : Stain</p>

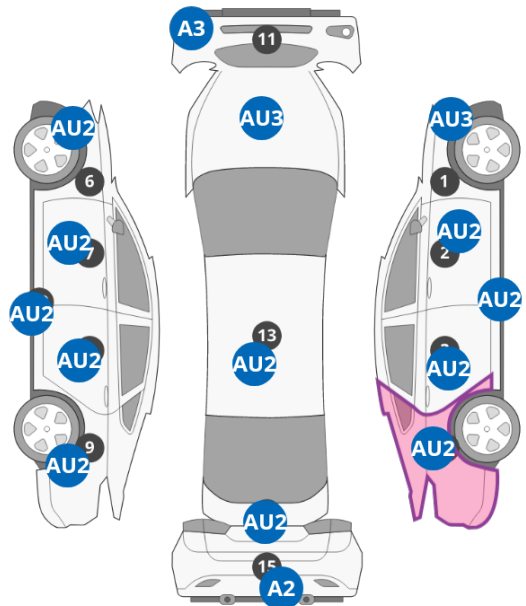
<p>A : Scratch AU : Scratch & Dent B : Modified C : Corrosion G : Stone chip P : Faded S : Rust SC : Rust & Corrosion U : Dent X : Defective Y : Crack, Gap</p>
<p>Remarks (L) Front Seat - Cut, Crack - Medium / (R) Front Seat - Cut, Crack - Medium / (L) Front Trim - Grime - Medium / (R) Front Trim - Grime - Small / Rear Seat - Grime - Small</p>	<p>Remarks (R) Front Door - Repair Traces - Yes / (R) Rear Fender - Repair Traces - Yes / (R) Rear Door - Repair Traces - Yes / Roof - Repair Traces - Yes / Bonnet, Headlight - Scratch & Dent - Medium / (R) Front Fender, Molding - Scratch & Dent - Medium / (R) Front Door, Molding - Scratch & Dent - Small / (R) Step, In-panel, Side Spoiler - Scratch & Dent - Small / (R) Rear Door, Molding - Scratch & Dent - Small / (R) Rear Fender, Molding - Scratch & Dent - Small / (R) Rear Fender, Molding - Repair mark - Yes / Trunk Hood, Rear Gate - Scratch & Dent - Small / Rear Bumper, Lamps, Panels - Scratch - Small / (L) Rear Fender, Molding - Scratch & Dent - Small / (L) Rear Door, Molding - Scratch & Dent - Small / (L) Front Door, Molding - Scratch & Dent - Small / (L) Step, In-panel, Side Spoiler - Scratch & Dent - Small / (L) Front Fender, Molding - Scratch & Dent - Small / Front Bumper, Grille, Lamps - Scratch - Medium</p>
