## General Information

<b>Make</b>	Toyota	<b>Model</b>	Vios
<b>YOM</b>	2025	<b>Odo Meter Reading</b>	7,959
<b>Registration No.</b>	NKU2945	<b>Chassis No.</b>	PA1B18F3XS4291841
<b>CC</b>	1.3	<b>Transmission</b>	CVT
<b>Fuel Type</b>	Gas	<b>Type of Body</b>	Sedan
<b>Colour</b>	Blue

## Body / Panel Condition

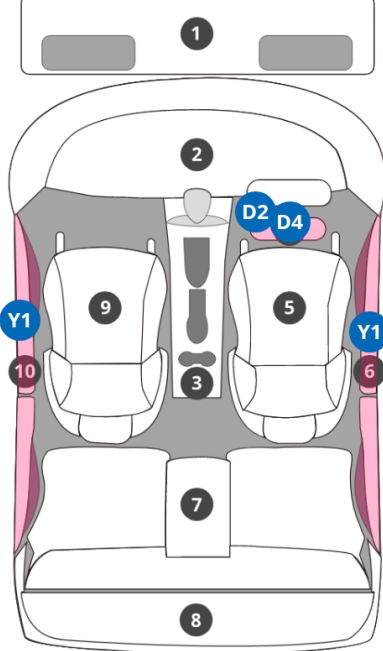
<b>Interior Evaluation :</b> <span style="float: right; color: red; font-weight: bold;">C</span>	<b>Exterior Evaluation :</b> <span style="float: right; color: red; font-weight: bold;">E</span>

<p><b>a</b> : Cut, Fray <b>d</b> : Loose, Deformed <b>k</b> : Animal Hair <b>s</b> : Smell <b>t</b> : Cigarette Burns <b>x</b> : Defective <b>y</b> : Stain</p>

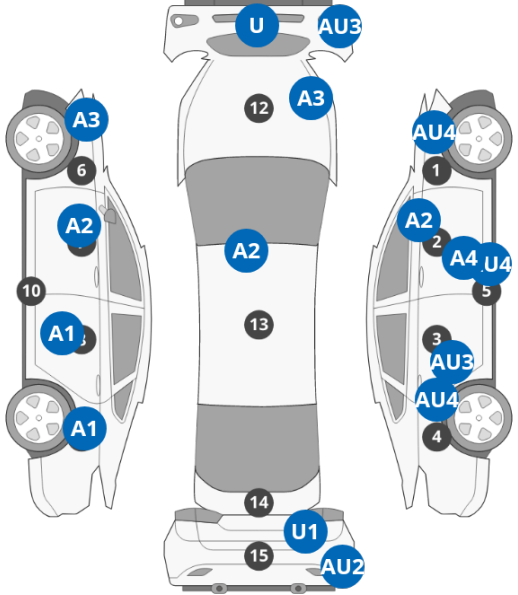
<p><b>A</b> : Scratch <b>AU</b> : Scratch &amp; Dent <b>B</b> : Modified <b>C</b> : Corrosion <b>G</b> : Stone chip <b>P</b> : Faded <b>S</b> : Rust <b>SC</b> : Rust &amp; Corrosion <b>U</b> : Dent <b>X</b> : Defective <b>Y</b> : Crack, Gap</p>
<p><b>Remarks</b> (L) Front Floor Mat - Worked - Small / Mat Other - Worked - Large / (R) Front Trim - Grime - Minimal / (L) Front Trim - Grime - Minimal</p>	<p><b>Remarks</b> (R) Front Fender, Molding - Scratch &amp; Dent - Large / Member (Bolted) - Dent - Yes / (R) Step, In-panel, Side Spoiler - Scratch &amp; Dent - Large / (R) Front Door, Molding - Scratch - Large / (R) Rear Door, Molding - Scratch &amp; Dent - Medium / (R) Rear Fender, Molding - Scratch &amp; Dent - Large / Rear Bumper, Lamps, Panels - Scratch &amp; Dent - Small / Trunk Hood, Rear Gate - Dent - Minimal / (L) Rear Fender, Molding - Scratch - Minimal / (L) Rear Door, Molding - Scratch - Minimal / (L) Front Door, Molding - Scratch - Small / (L) Front Fender, Molding - Scratch - Medium / Front Bumper, Grille, Lamps - Scratch &amp; Dent - Medium / (R) Mirror - Scratch - Small / Bonnet, Headlight - Scratch - Medium / Roof - Scratch - Small</p>

<p><b>Inspector Notes</b></p>
<p>with warranty booklet, jack and tools, with spare tire, no LTO plate, scratches on tail light</p>
