General Information

Make	Toyota	Model	Vios
YOM	2021	Odo Meter Reading	41,651
Registration No.	NGY2640	Chassis No.	PA1B18F38M4138944
CC	1.3	Transmission	CVT
Fuel Type	Gas	Type of Body	Sedan
Colour	White

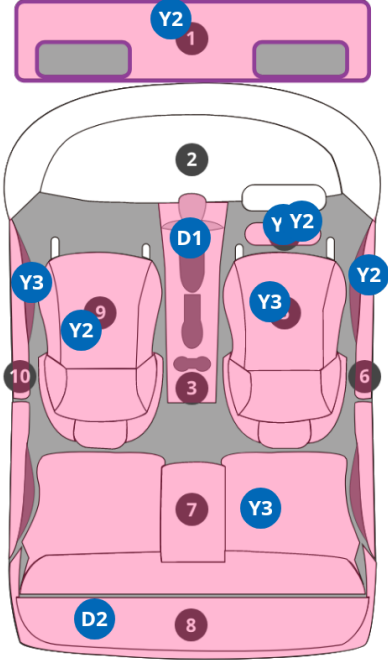
Interior Evaluation : C	Exterior Evaluation : E

<p>a : Cut, Fray d : Loose, Deformed k : Animal Hair s : Smell t : Cigarette Burns x : Defective y : Stain</p>

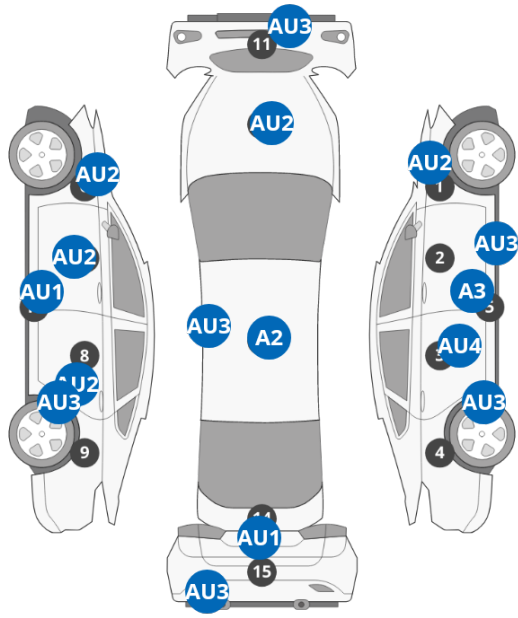
<p>A : Scratch AU : Scratch & Dent B : Modified C : Corrosion G : Stone chip P : Faded S : Rust SC : Rust & Corrosion U : Dent X : Defective Y : Crack, Gap</p>
<p>Remarks (R) Front Seat - Grime - Medium / (L) Front Seat - Grime - Small / (L) Front Trim - Grime - Medium / (L) Front Floor Mat - Grime - Small / (R) Front Floor Mat - Grime - Small / (R) Front Trim - Grime - Small / Rear Seat - Grime - Medium / Console, Switchs, Vents - Worked - Minimal / Ceiling - Grime - Small / Trunk Room - Loose, Deformed - Small / Room Lamp - Missing - Yes</p>	<p>Remarks (R) Front Fender - Repair Traces - Yes / Bonnet - Repair Traces - Yes / (L) Front Fender - Repair Traces - Yes / (L) Front Door - Repair Traces - Yes / (L) Rear Door - Repair Traces - Yes / Trunk Hood, Rear Gate - Repair Traces - Yes / Overall Exterior - Full Re-Paint in same color - Yes / Roof Spoiler, Molding - Scratch & Dent - Medium / (L) Rear Door, Molding - Scratch & Dent - Small / (L) Rear Fender, Molding - Scratch & Dent - Medium / (L) Step, In-panel, Side Spoiler - Scratch & Dent - Minimal / Trunk Hood, Rear Gate - Scratch & Dent - Minimal / Rear Bumper, Lamps, Panels - Scratch & Dent - Medium / (R) Front Fender, Molding - Scratch & Dent - Small / Bonnet, Headlight - Scratch & Dent - Small / (L) Front Fender, Molding - Scratch & Dent - Small / Front Bumper, Grille, Lamps - Scratch & Dent - Medium / (L) Front Door, Molding - Scratch & Dent - Small / (R) Rear Fender, Molding - Scratch & Dent - Medium / (R) Rear Door, Molding - Scratch & Dent - Large / (R) Front Door, Molding - Scratch - Medium / (R) Step, In-panel, Side Spoiler - Scratch & Dent - Medium / Roof - Scratch - Small</p>
