## General Information

| Make | Toyota | Model | Vios |
| Registration No. | NFE3596 | Chassis No. | PA1B18F32N4182603 |

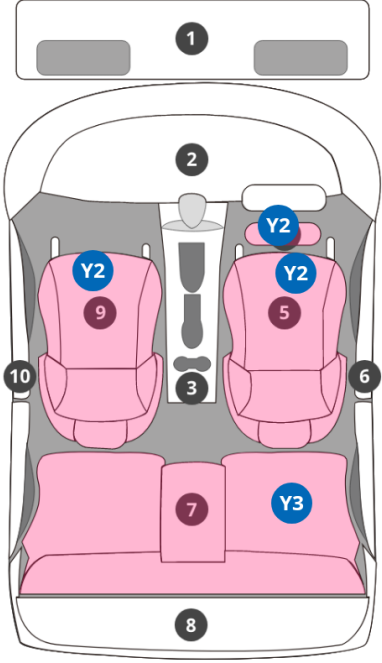
| <b>Remarks</b><br>(R) Front Seat - Grime - Small / Rear Seat - Grime - Medium / (L) Front Seat - Grime - Small / (L) Front Floor Mat - Grime - Small | <b>Remarks</b><br>Rear Bumper, Lamps, Panels - Scratch & Dent - Medium / (L) Rear Door, Molding - Dent - Medium / (L) Mirror - Scratch - Small / (L) Front Fender, Molding - Scratch - Small / Front Bumper, Grille, Lamps - Scratch - Large / (R) Front Fender, Molding - Scratch & Dent - Medium / (R) Front Door, Molding - Scratch & Dent - Medium / (R) Step, In-panel, Side Spoiler - Scratch & Dent - Medium / (R) Rear Door, Molding - Dent - Minimal / Trunk Hood, Rear Gate - Scratch & Dent - Medium / (L) Rear Fender, Molding - Dent - Small |
