General Information

Make	Toyota	Model	Vios
YOM	2023	Odo Meter Reading	30,001
Registration No.	DBH8943	Chassis No.	PA1B18F31P4211950
CC	1.3	Transmission	CVT
Fuel Type	Gas	Type of Body	Sedan
Colour	Blue

Body / Panel Condition

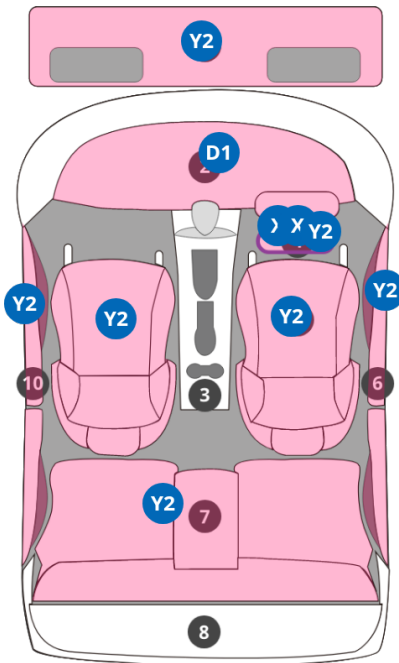
Interior Evaluation : B	Exterior Evaluation : D

<p>a : Cut, Fray d : Loose, Deformed k : Animal Hair s : Smell t : Cigarette Burns x : Defective y : Stain</p>

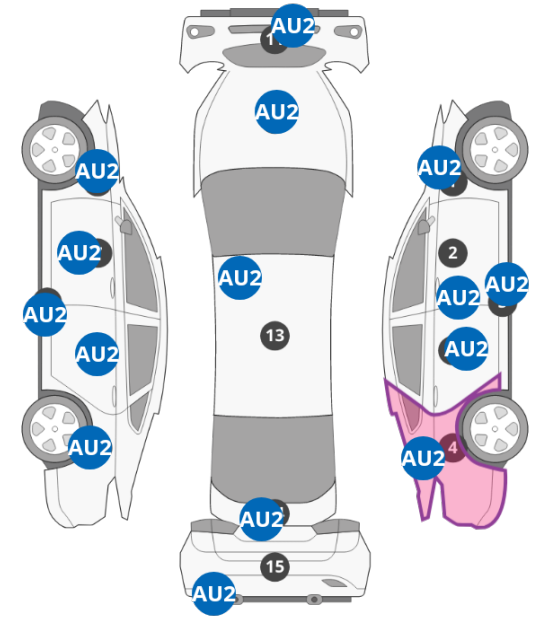
<p>A : Scratch AU : Scratch & Dent B : Modified C : Corrosion G : Stone chip P : Faded S : Rust SC : Rust & Corrosion U : Dent X : Defective Y : Crack, Gap</p>
Remarks Rear Seat - Grime - Small / (L) Front Trim - Grime - Small / (R) Front Trim - Grime - Small / (L) Front Seat - Grime - Small / (R) Front Seat - Grime - Small / (L) Front Floor Mat - Missing - Yes / Mat Other - Missing - Yes / (R) Front Floor Mat - Grime - Small / Ceiling - Grime - Small / Dashboard - Worked - Minimal	Remarks Bonnet - Repair Traces - Yes / (L) Rear Door, Molding - Scratch & Dent - Small / (L) Rear Fender, Molding - Scratch & Dent - Small / Trunk Hood, Rear Gate - Scratch & Dent - Small / Rear Bumper, Lamps, Panels - Scratch & Dent - Small / (R) Rear Fender, Molding - Scratch & Dent - Small / (R) Rear Door, Molding - Scratch & Dent - Small / (R) Step, In-panel, Side Spoiler - Scratch & Dent - Small / (R) Front Door, Molding - Scratch & Dent - Small / Roof - Scratch & Dent - Small / (R) Front Fender, Molding - Scratch & Dent - Small / Front Bumper, Grille, Lamps - Scratch & Dent - Small / (L) Step, In-panel, Side Spoiler - Scratch & Dent - Small / (L) Front Door, Molding - Scratch & Dent - Small / Bonnet, Headlight - Scratch & Dent - Small / (L) Front Fender, Molding - Scratch & Dent - Small / (R) Rear Fender, Molding - Repair mark - Yes
