General Information

Make	Toyota	Model	Rush
YOM	2022	Odo Meter Reading	116,699
Registration No.	NGY7706	Chassis No.	MHKE8FF3PNK042075
CC	1.5	Transmission	A/T
Fuel Type	Gas	Type of Body	SUV
Colour	Blackish Red Mica

Body / Panel Condition

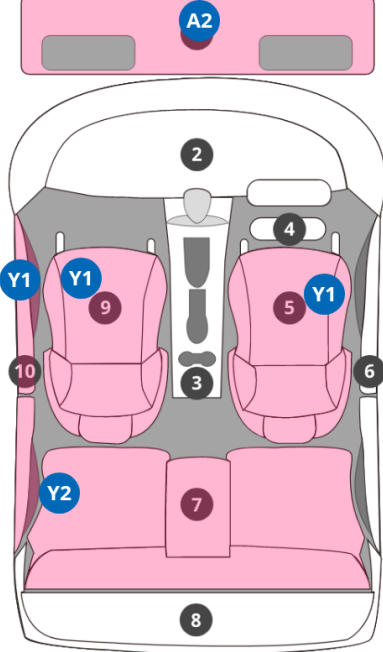
Interior Evaluation : A	Exterior Evaluation : D

<p>a : Cut, Fray d : Loose, Deformed k : Animal Hair s : Smell t : Cigarette Burns x : Defective y : Stain</p>

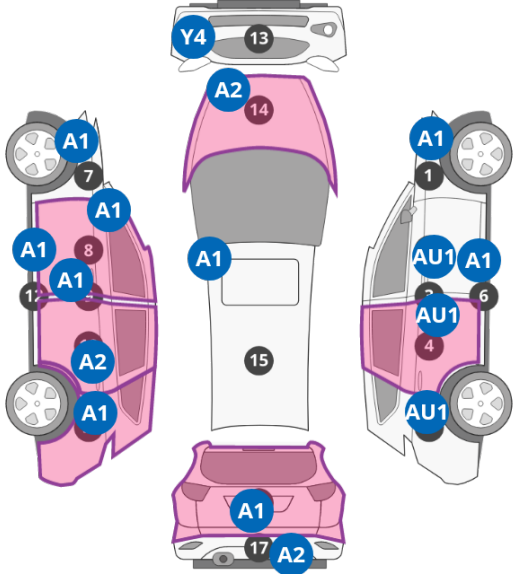
<p>A : Scratch AU : Scratch & Dent B : Modified C : Corrosion G : Stone chip P : Faded S : Rust SC : Rust & Corrosion U : Dent X : Defective Y : Crack, Gap</p>
<p>Remarks Ceiling - Cut, Crack - Small / (L) Front Seat - Grime - Minimal / (R) Front Seat - Grime - Minimal / Rear Seat - Grime - Small / (L) Front Trim - Grime - Minimal</p>	<p>Remarks (R) Front Door - Repair Traces - Yes / (R) Front Fender - Repair Traces - Yes / Bonnet - Repair Traces - Yes / (L) Front Fender - Repair Traces - Yes / (L) Front Door - Repair Traces - Yes / (L) Rear Door - Repair Traces - Yes / (L) Rear Fender - Repair Traces - Yes / Trunk Hood, Rear Gate - Repair Traces - Yes / (R) Rear Fender - Repair Traces - Yes / (R) Rear Door - Repair Traces - Yes / Roof - Repair Traces - Yes / Overall Exterior - Full Re-Paint in same color - Yes / (R) Front Fender, Molding - Scratch - Minimal / (R) Front Door, Molding - Scratch & Dent - Minimal / (R) Step, In-panel, Side Spoiler - Scratch - Minimal / (R) Rear Door, Molding - Scratch & Dent - Minimal / (R) Rear Door, Molding - Repair mark - Yes / (R) Rear Fender, Molding - Scratch & Dent - Minimal / Trunk Hood, Rear Gate - Repair mark - Yes / Trunk Hood, Rear Gate - Scratch - Minimal / Rear Bumper, Lamps, Panels - Scratch - Small / (L) Rear Fender, Molding - Repair mark - Yes / (L) Rear Fender, Molding - Scratch - Minimal / (L) Rear Door, Molding - Repair mark - Yes / (L) Rear Door, Molding - Scratch - Small / (L) Step, In-panel, Side Spoiler - Scratch - Minimal / (L) Mirror - Scratch - Minimal / (L) Front Door, Molding - Repair mark - Yes / (L) Front Door, Molding - Scratch - Minimal / Roof - Scratch - Minimal / (L) Front Fender, Molding - Scratch - Minimal / Front Bumper, Grille, Lamps - Crack, Gap - Large / Bonnet, Headlight - Scratch - Small / Bonnet, Headlight - Repair mark - Yes</p>

With Lto plate,with warranty booklet, with spare tire, 1key, no jack and tools, scratches on headlights and taillights
