General Information

Make	Nissan	Model	NV350
YOM	2022	Odo Meter Reading	153,991
Registration No.	NFL3837	Chassis No.	JN1TCE26Z0082109
CC	2.5	Transmission	M/T
Fuel Type	Diesel	Type of Body	Van
Colour	Silver

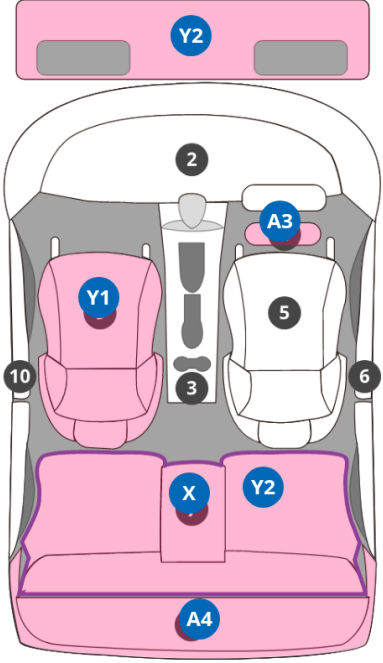
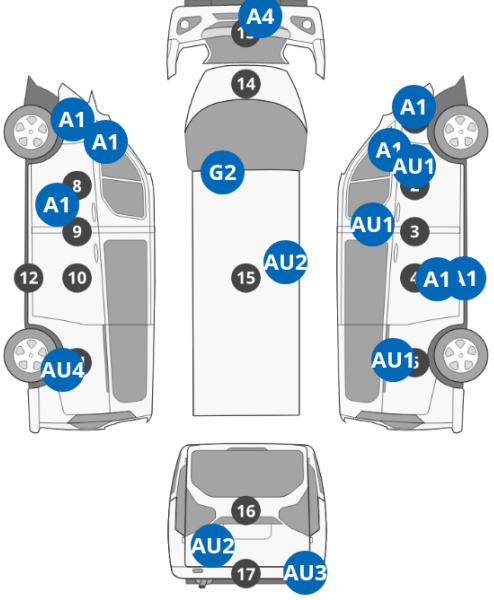
Interior Evaluation :	C	Exterior Evaluation :	C

<p>a : Cut, Fray d : Loose, Deformed k : Animal Hair s : Smell t : Cigarette Burns x : Defective y : Stain</p>		<p>A : Scratch AU : Scratch & Dent B : Modified C : Corrosion G : Stone chip P : Faded S : Rust SC : Rust & Corrosion U : Dent X : Defective Y : Crack, Gap</p>	
<p>Remarks Rear Seat - Partially Missing - Yes / (L) Front Floor Mat - Cut, Crack - Medium / (L) Front Seat - Grime - Minimal / Ceiling - Grime - Small / Trunk Room - Worn, Scratch, Cut, Crack - Large / Rear Seat - Grime - Small</p>		<p>Remarks (R) Rear Fender - Repair Traces - Yes / (R) Front Fender, Molding - Scratch - Minimal / (R) Mirror - Scratch - Minimal / (R) Front Door, Molding - Scratch & Dent - Minimal / (R) Center Panel - Scratch & Dent - Minimal / Roof - Scratch & Dent - Small / (R) Step, In-panel, Side Spoiler - Scratch - Minimal / (R) Rear Door, Molding - Scratch - Minimal / (R) Rear Fender, Molding - Scratch & Dent - Minimal / Trunk Hood, Rear Gate - Scratch & Dent - Small / Rear Bumper, Lamps, Panels - Scratch & Dent - Medium / (L) Rear Fender, Molding - Scratch & Dent - Large / (L) Mirror - Scratch - Minimal / (L) Front Door, Molding - Scratch - Minimal / (L) Front Fender, Molding - Scratch - Minimal / Front Windshield - Scratch, Stone chip - Small / Front Bumper, Grille, Lamps - Scratch - Large</p>

Inspector Notes
With Lto plate, with spare tire and jack, 1key, no warranty booklet and tools, scratches on headlights and taillights,incomplete rearseat
