General Information

Make	Toyota	Model	Avanza
YOM	2019	Odo Meter Reading	37,354
Registration No.	NBF8651	Chassis No.	MHKM5EF2FJK017529
CC	1.3	Transmission	A/T
Fuel Type	Gas	Type of Body	Wagon
Colour	Gray

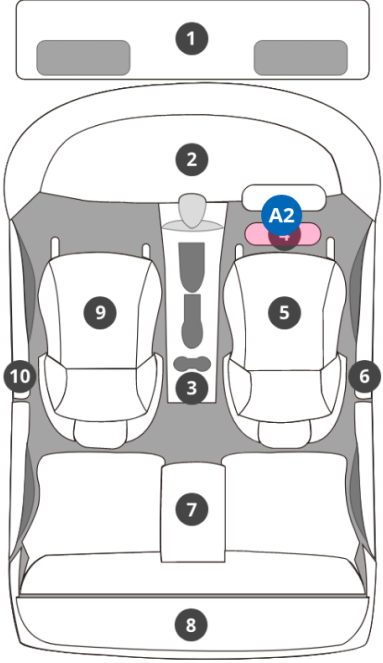
<p>a : Cut, Fray d : Loose, Deformed k : Animal Hair s : Smell t : Cigarette Burns x : Defective y : Stain</p>

<p>A : Scratch AU : Scratch & Dent B : Modified C : Corrosion G : Stone chip P : Faded S : Rust SC : Rust & Corrosion U : Dent X : Defective Y : Crack, Gap</p>
Remarks (L) Front Floor Mat - Cut, Crack - Small	Remarks Bonnet - Repair Traces - Yes / (L) Rear Fender - Repair Traces - Yes / (R) Front Fender, Molding - Scratch - Minimal / (R) Front Door, Molding - Scratch & Dent - Small / (R) Step, In-panel, Side Spoiler - Scratch & Dent - Minimal / (R) Rear Door, Molding - Scratch & Dent - Minimal / (R) Rear Fender, Molding - Scratch - Small / Rear Bumper, Lamps, Panels - Scratch & Dent - Medium / Trunk Hood, Rear Gate - Scratch - Minimal / (L) Rear Fender, Molding - Scratch & Dent - Medium / (L) Rear Door, Molding - Scratch - Minimal / Roof - Scratch - Minimal / (L) Front Door, Molding - Scratch - Minimal / (L) Mirror - Scratch - Minimal / (L) Front Fender, Molding - Scratch - Minimal / Front Bumper, Grille, Lamps - Scratch & Dent - Medium / Bonnet, Headlight - Scratch - Minimal

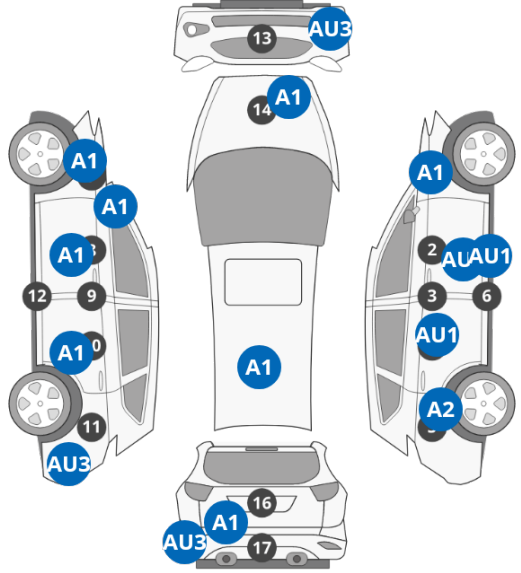
Inspector Notes
With Lto plate, with warranty booklet, with spare tire, 2keys, no jack and tools, scratches on headlights and taillights
