General Information

Make	Nissan	Model	NV350
YOM	2018	Odo Meter Reading	139,978
Registration No.	NCT8185	Chassis No.	JN1TCE26Z0050518
CC	2.5	Transmission	M/T
Fuel Type	Diesel	Type of Body	Van
Colour	Silver

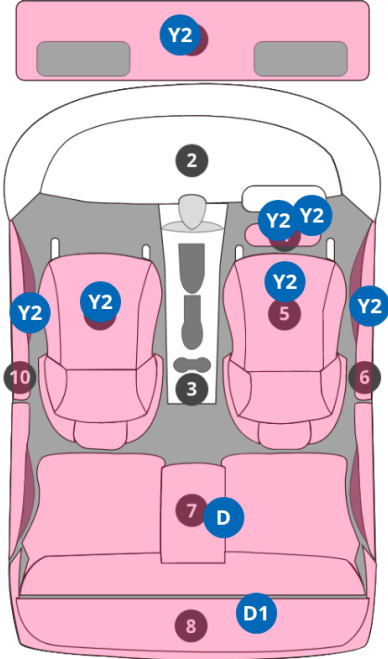
Interior Evaluation : C	Exterior Evaluation : E

<p>a : Cut, Fray d : Loose, Deformed k : Animal Hair s : Smell t : Cigarette Burns x : Defective y : Stain</p>

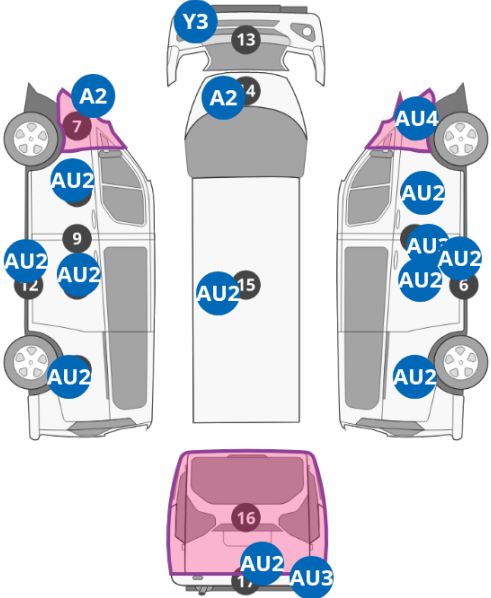
<p>A : Scratch AU : Scratch & Dent B : Modified C : Corrosion G : Stone chip P : Faded S : Rust SC : Rust & Corrosion U : Dent X : Defective Y : Crack, Gap</p>
<p>Remarks (L) Front Seat - Grime - Small / (R) Front Seat - Grime - Small / (L) Front Trim - Grime - Small / (R) Front Trim - Grime - Small / Rear Seat - Worn - Yes / (R) Front Floor Mat - Grime - Small / (L) Front Floor Mat - Grime - Small / Ceiling - Grime - Small / Trunk Room - Worked - Minimal</p>	<p>Remarks (R) Front Door - Repair Traces - Yes / Front Panel - Repair Traces - Yes / (L) Front Door - Repair Traces - Yes / (L) Rear Fender - Repair Traces - Yes / Trunk Hood, Rear Gate - Repair Traces - Yes / (R) Rear Fender - Repair Traces - Yes / (R) Rear Door - Repair Traces - Yes / (R) Center Panel - Repair Traces - Yes / Roof - Repair Traces - Yes / Roof - Scratch & Dent - Small / (L) Front Door, Molding - Scratch & Dent - Small / Overall Exterior - Full Re-Paint in same color - Yes / (L) Front Fender, Molding - Repair mark - Yes / (L) Front Fender, Molding - Scratch - Small / Front Panel - Scratch - Small / (R) Front Fender, Molding - Repair mark - Yes / (R) Front Fender, Molding - Scratch & Dent - Large / (R) Front Door, Molding - Scratch & Dent - Small / (R) Center Panel - Scratch & Dent - Medium / (R) Rear Door, Molding - Scratch & Dent - Small / (R) Rear Fender, Molding - Scratch & Dent - Small / Rear Bumper, Lamps, Panels - Scratch & Dent - Medium / Trunk Hood, Rear Gate - Scratch & Dent - Small / Trunk Hood, Rear Gate - Repair mark - Yes / (L) Rear Fender, Molding - Scratch & Dent - Small / (L) Rear Door, Molding - Scratch & Dent - Small / (L) Step, In-panel, Side Spoiler - Scratch & Dent - Small / (R) Step, In-panel, Side Spoiler - Scratch & Dent - Small / Front Bumper, Grille, Lamps - Crack, Gap - Medium</p>
