General Information

Make	Suzuki	Model	APV
YOM	2020	Odo Meter Reading	57,195
Registration No.	NGD8391	Chassis No.	MHYDN7V4MJ400273
CC	1.6	Transmission	M/T
Fuel Type	Gas	Type of Body	Mini Van
Colour	White

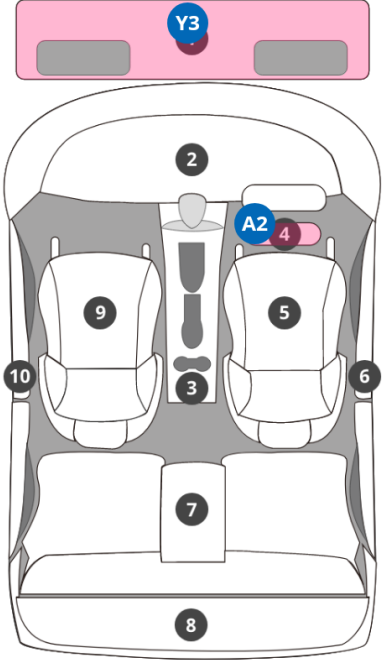
Interior Evaluation : B	Exterior Evaluation : D

<p>a : Cut, Fray d : Loose, Deformed k : Animal Hair s : Smell t : Cigarette Burns x : Defective y : Stain</p>

<p>A : Scratch AU : Scratch & Dent B : Modified C : Corrosion G : Stone chip P : Faded S : Rust SC : Rust & Corrosion U : Dent X : Defective Y : Crack, Gap</p>
<p>Remarks Carpet - Worn, Scratch, Cut, Crack - Small / Ceiling - Grime - Medium</p>	<p>Remarks (R) Front Fender, Molding - Scratch - Minimal / (R) Mirror - Scratch - Minimal / (R) Front Door, Molding - Scratch & Dent - Minimal / (R) Step, In-panel, Side Spoiler - Scratch - Small / (R) Rear Door, Molding - Scratch - Minimal / (R) Rear Fender, Molding - Scratch & Dent - Small / Rear Bumper, Lamps, Panels - Scratch & Dent - Medium / Trunk Hood, Rear Gate - Scratch & Dent - Large / Roof - Dent - Medium / (L) Rear Fender, Molding - Scratch & Dent - Small / (L) Rear Door, Molding - Scratch & Dent - Minimal / (L) Front Door, Molding - Scratch - Minimal / (L) Mirror - Faded(Color, Gloss) - Yes / (L) Front Fender, Molding - Scratch - Minimal / Front Bumper, Grille, Lamps - Crack, Gap - Small / Front Windshield - Scratch, Stone chip - Small / Bonnet, Headlight - Scratch - Minimal</p>
