General Information

Make	Toyota	Model	Vios
YOM	2025	Odo Meter Reading	27,218
Registration No.	FAS2772	Chassis No.	PA1B18F35R4275041
CC	1.3	Transmission	CVT
Fuel Type	Gas	Type of Body	Sedan
Colour	Silver

Body / Panel Condition

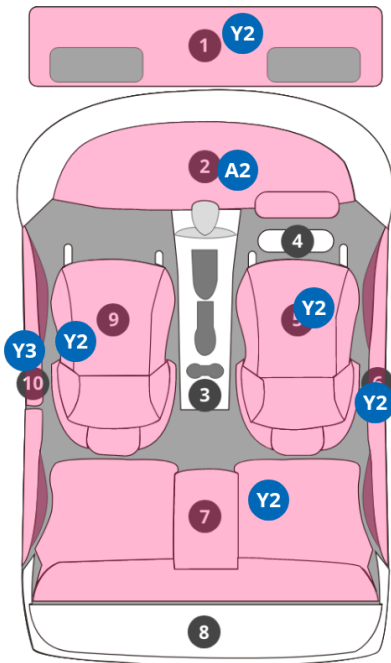
Interior Evaluation : B	Exterior Evaluation : B

<p>a : Cut, Fray d : Loose, Deformed k : Animal Hair s : Smell t : Cigarette Burns x : Defective y : Stain</p>

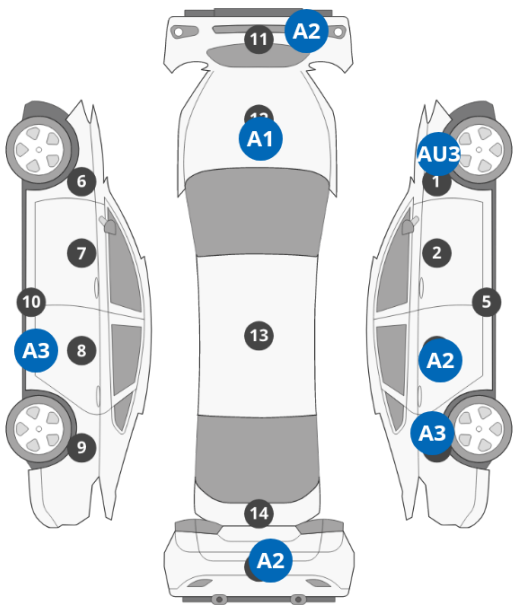
<p>A : Scratch AU : Scratch & Dent B : Modified C : Corrosion G : Stone chip P : Faded S : Rust SC : Rust & Corrosion U : Dent X : Defective Y : Crack, Gap</p>
<p>Remarks (L) Front Trim - Grime - Medium / (L) Front Seat - Grime - Small / Ceiling - Grime - Small / (R) Rear Trim - Grime - Small / (R) Front Seat - Grime - Small / Dashboard - Worn, Scratch, Cut, Crack - Small / Rear Seat - Grime - Small</p>	<p>Remarks (R) Front Fender - Repair Traces - Yes / (R) Front Fender, Molding - Scratch & Dent - Medium / (R) Rear Fender, Molding - Scratch - Medium / Trunk Hood, Rear Gate - Scratch - Small / (L) Rear Door, Molding - Scratch - Medium / (R) Rear Door, Molding - Scratch - Small / Bonnet, Headlight - Scratch - Minimal</p>
Frame Evaluation : A	Functional Evaluation : B
