General Information

Make	Toyota	Model	Vios
YOM	2024	Odo Meter Reading	29,866
Registration No.	FAR9994	Chassis No.	PA1B18F37R4261349
CC	1.3	Transmission	CVT
Fuel Type	Gas	Type of Body	Sedan
Colour	Red

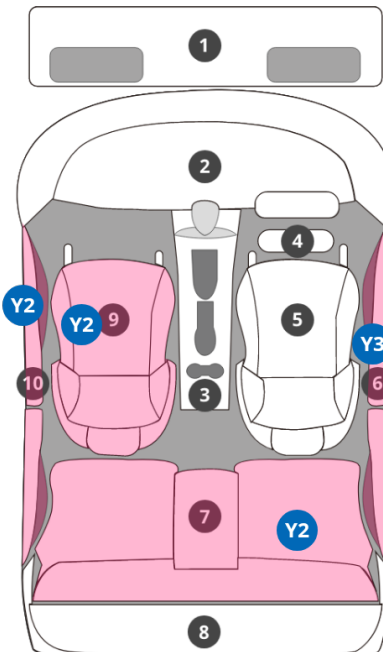
Interior Evaluation : B	Exterior Evaluation : C

<p>a : Cut, Fray d : Loose, Deformed k : Animal Hair s : Smell t : Cigarette Burns x : Defective y : Stain</p>

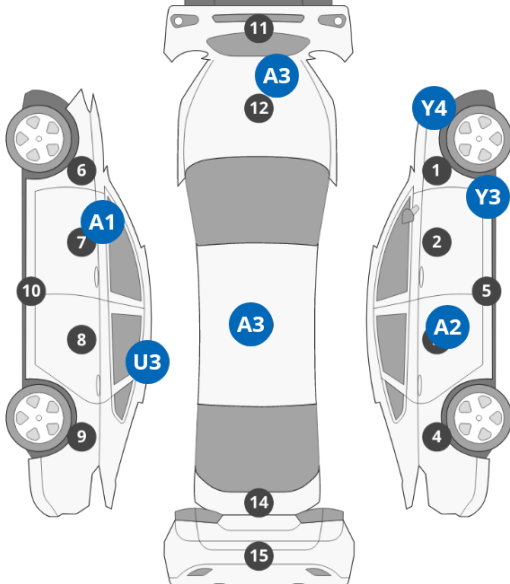
<p>A : Scratch AU : Scratch & Dent B : Modified C : Corrosion G : Stone chip P : Faded S : Rust SC : Rust & Corrosion U : Dent X : Defective Y : Crack, Gap</p>
<p>Remarks (R) Front Trim - Grime - Medium / (L) Front Trim - Grime - Small / (L) Front Seat - Grime - Small / Rear Seat - Grime - Small</p>	<p>Remarks (R) Front Door - Repair Traces - Yes / (R) Front Fender - Repair Traces - Yes / Bonnet - Repair Traces - Yes / (L) Front Fender - Repair Traces - Yes / (L) Front Door - Repair Traces - Yes / (L) Rear Door - Repair Traces - Yes / (L) Rear Fender - Repair Traces - Yes / Trunk Hood, Rear Gate - Repair Traces - Yes / (R) Rear Fender - Repair Traces - Yes / (R) Rear Door - Repair Traces - Yes / Roof - Repair Traces - Yes / (R) Front Fender, Molding - Crack, Gap - Large / (R) Front Door, Molding - Crack, Gap - Medium / (R) Rear Door, Molding - Scratch - Small / (L) Rear Door, Molding - Dent - Medium / (L) Mirror - Scratch, Peeled - Minimal / Bonnet, Headlight - Scratch - Medium / Roof - Scratch - Medium</p>
