General Information

Make	Toyota	Model	Vios
YOM	2023	Odo Meter Reading	14,675
Registration No.	FAN9126	Chassis No.	PA1B18F31N4198713
CC	1.3	Transmission	CVT
Fuel Type	Gas	Type of Body	Sedan
Colour	Blue

Body / Panel Condition

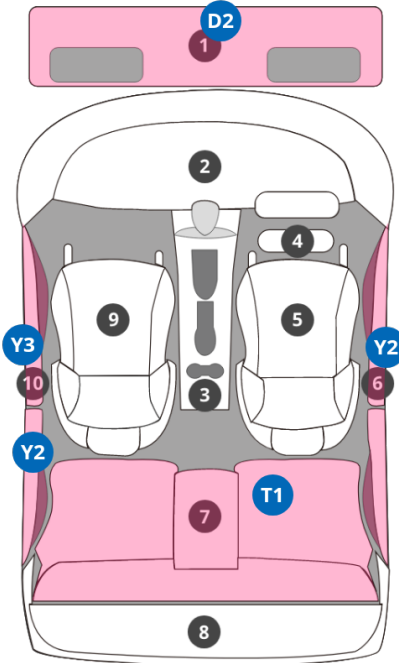
<p>a : Cut, Fray d : Loose, Deformed k : Animal Hair s : Smell t : Cigarette Burns x : Defective y : Stain</p>

<p>A : Scratch AU : Scratch & Dent B : Modified C : Corrosion G : Stone chip P : Faded S : Rust SC : Rust & Corrosion U : Dent X : Defective Y : Crack, Gap</p>
<p>Remarks (R) Front Trim - Grime - Small / Rear Seat - Cigarette Burns - Burnt Minimal / Ceiling - Crinkle - Small / (L) Rear Trim - Grime - Small / (L) Front Trim - Grime - Medium</p>	<p>Remarks (R) Step - Repair Traces - Yes / (R) Rear Door, Molding - Scratch - Small / (R) Rear Fender, Molding - Scratch - Small / Trunk Hood, Rear Gate - Scratch - Medium / (L) Front Door, Molding - Scratch - Small / (L) Rear Door, Molding - Scratch & Dent - Large / (L) Front Fender, Molding - Scratch - Minimal / (R) Front Door, Molding - Scratch - Medium</p>
Frame Evaluation : B	Functional Evaluation : B
