General Information

Make	Toyota	Model	Wigo
YOM	2020	Odo Meter Reading	47,525
Registration No.	FAL7004	Chassis No.	MHKA4DE5FLJ014575
CC	1.0	Transmission	M/T
Fuel Type	Gas	Type of Body	Hatchback
Colour	Black

Body / Panel Condition

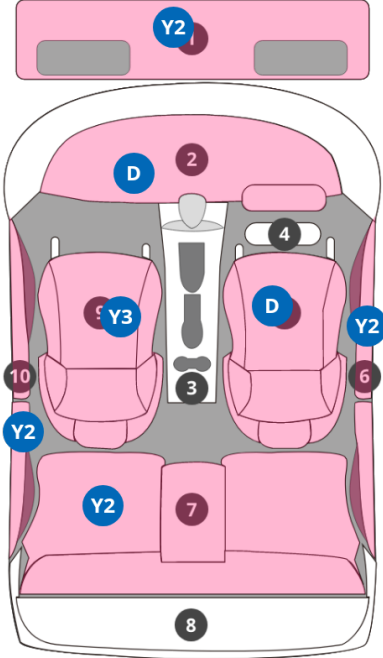
Interior Evaluation : B	Exterior Evaluation : C

<p>a : Cut, Fray d : Loose, Deformed k : Animal Hair s : Smell t : Cigarette Burns x : Defective y : Stain</p>

<p>A : Scratch AU : Scratch & Dent B : Modified C : Corrosion G : Stone chip P : Faded S : Rust SC : Rust & Corrosion U : Dent X : Defective Y : Crack, Gap</p>
Remarks (R) Front Trim - Grime - Small / (R) Front Seat - Worn - Yes / (L) Front Seat - Grime - Medium / Dashboard - Traces of Adhesive Tape - Yes / Rear Seat - Grime - Small / Ceiling - Grime - Small / (L) Rear Trim - Grime - Small	Remarks (R) Front Door - Repair Traces - Yes / (R) Step - Replaced - Yes / Front Bumper, Grille, Lamps - Scratch & Dent - Medium / (R) Front Fender, Molding - Scratch - Medium / (R) Front Door, Molding - Dent - Small / (R) Rear Door, Molding - Scratch - Small / (R) Rear Fender, Molding - Crack, Gap - Small / Rear Bumper, Lamps, Panels - Modified - Large / (L) Rear Door, Molding - Scratch - Small / (L) Front Door, Molding - Scratch - Small / Overall Exterior - Faded(Color, Gloss) - Yes / (L) Side Window - Scratch, Stone chip - Small

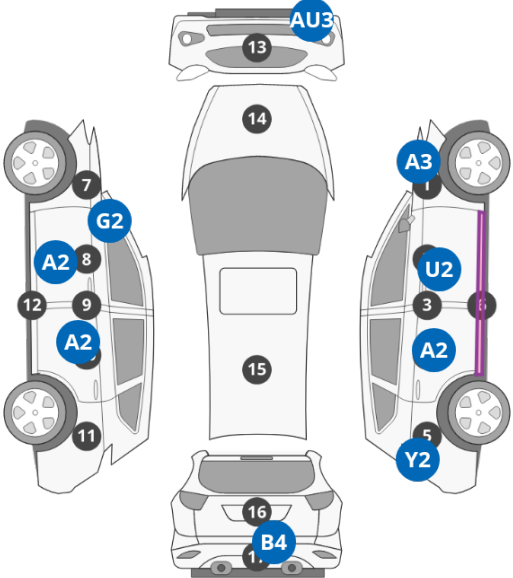
Inspector Notes
with spare tire. no jack and tools.with seat cover. no Battery. front and rear window damage spoiler.fade color.
