General Information

Make	Geely	Model	Okavango
YOM	2021	Odo Meter Reading	64,738
Registration No.	NEV1725	Chassis No.	L877922Z1MY021279
CC	1.5	Transmission	A/T
Fuel Type	Gas	Type of Body	SUV
Colour	Black

Body / Panel Condition

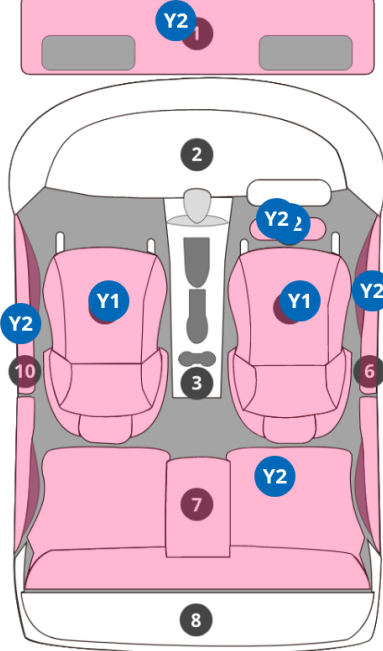
Interior Evaluation : B	Exterior Evaluation : E

<p>a : Cut, Fray d : Loose, Deformed k : Animal Hair s : Smell t : Cigarette Burns x : Defective y : Stain</p>

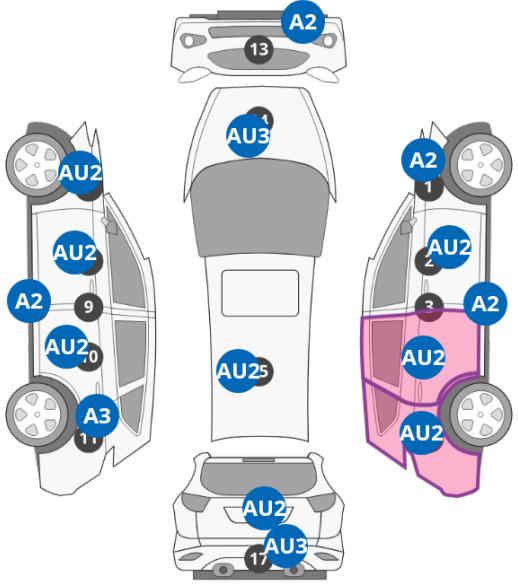
<p>A : Scratch AU : Scratch & Dent B : Modified C : Corrosion G : Stone chip P : Faded S : Rust SC : Rust & Corrosion U : Dent X : Defective Y : Crack, Gap</p>
<p>Remarks (L) Front Seat - Grime - Minimal / (R) Front Seat - Grime - Minimal / (L) Front Trim - Grime - Small / (R) Front Trim - Grime - Small / Rear Seat - Grime - Small / Ceiling - Grime - Small / (R) Front Floor Mat - Grime - Small / (L) Front Floor Mat - Grime - Small</p>	<p>Remarks (L) Rear Door, Molding - Scratch & Dent - Small / (L) Front Door, Molding - Scratch & Dent - Small / (L) Front Fender, Molding - Scratch & Dent - Small / Bonnet, Headlight - Scratch & Dent - Medium / Front Bumper, Grille, Lamps - Scratch - Small / (R) Front Fender, Molding - Scratch - Small / (R) Front Door, Molding - Scratch & Dent - Small / (R) Rear Door, Molding - Scratch & Dent - Small / (R) Rear Door, Molding - Repair mark - Yes / (R) Rear Fender, Molding - Repair mark - Yes / (R) Rear Fender, Molding - Scratch & Dent - Small / Trunk Hood, Rear Gate - Scratch & Dent - Small / Rear Bumper, Lamps, Panels - Scratch & Dent - Medium / (L) Rear Fender, Molding - Scratch - Medium / (L) Step, In-panel, Side Spoiler - Scratch - Small / (R) Step, In-panel, Side Spoiler - Scratch - Small / Roof - Scratch & Dent - Small</p>
