## General Information

<b>Make</b>	Toyota	<b>Model</b>	Hiace
<b>YOM</b>	2018	<b>Odo Meter Reading</b>	198,347
<b>Registration No.</b>	NCR3856	<b>Chassis No.</b>	JTFRT13P9J8023915
<b>CC</b>	3.0	<b>Transmission</b>	A/T
<b>Fuel Type</b>	Diesel	<b>Type of Body</b>	Van
<b>Colour</b>	Pearl White

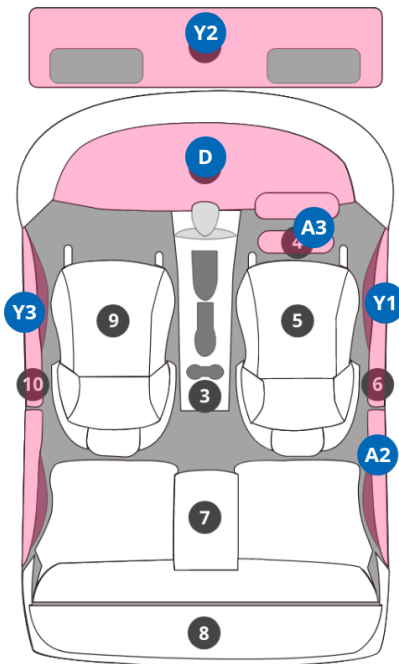
<b>Interior Evaluation :</b> <span style="float: right; color: red; font-weight: bold;">C</span>	<b>Exterior Evaluation :</b> <span style="float: right; color: red; font-weight: bold;">E</span>

<p><b>a</b> : Cut, Fray <b>d</b> : Loose, Deformed <b>k</b> : Animal Hair <b>s</b> : Smell <b>t</b> : Cigarette Burns <b>x</b> : Defective <b>y</b> : Stain</p>

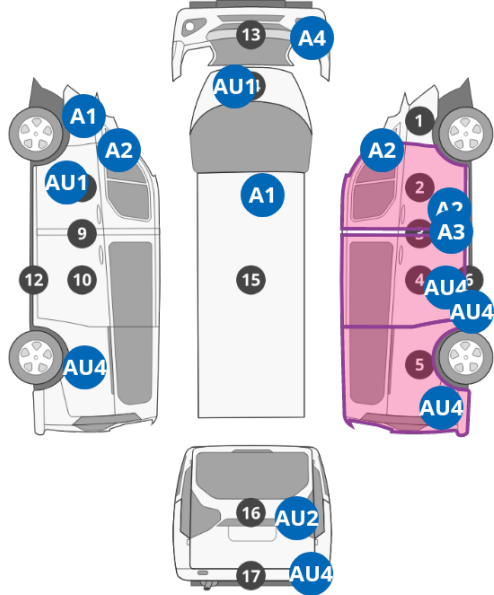
<p><b>A</b> : Scratch <b>AU</b> : Scratch &amp; Dent <b>B</b> : Modified <b>C</b> : Corrosion <b>G</b> : Stone chip <b>P</b> : Faded <b>S</b> : Rust <b>SC</b> : Rust &amp; Corrosion <b>U</b> : Dent <b>X</b> : Defective <b>Y</b> : Crack, Gap</p>
<p><b>Remarks</b>  (L) Front Trim - Grime - Medium / Dashboard - Traces of Adhesive Tape - Yes / Overall Interior - Worn as per age - Yes / Carpet - Worn, Scratch, Cut, Crack - Medium / Ceiling - Grime - Small / (R) Front Trim - Grime - Minimal / Trim Other - Cut, Crack - Small</p>	<p><b>Remarks</b>  (R) Front Door - Repair Traces - Yes / (R) Front Fender - Repair Traces - Yes / Bonnet - Repair Traces - Yes / (L) Front Fender - Repair Traces - Yes / (L) Front Door - Repair Traces - Yes / (L) Rear Fender - Repair Traces - Yes / Trunk Hood, Rear Gate - Repair Traces - Yes / (R) Rear Fender - Repair Traces - Yes / (R) Rear Door - Repair Traces - Yes / (R) Center Panel - Repair Traces - Yes / Roof - Repair Traces - Yes / (R) Mirror - Scratch - Small / Overall Exterior - Re-Paint Uneven - Yes / (R) Front Door, Molding - Scratch - Small / (R) Center Panel - Scratch - Medium / (R) Rear Door, Molding - Scratch &amp; Dent - Large / (R) Step, In-panel, Side Spoiler - Scratch &amp; Dent - Large / (R) Rear Fender, Molding - Scratch &amp; Dent - Large / Rear Bumper, Lamps, Panels - Scratch &amp; Dent - Large / Trunk Hood, Rear Gate - Scratch &amp; Dent - Small / (L) Rear Fender, Molding - Scratch &amp; Dent - Large / (L) Mirror - Scratch - Small / (L) Front Door, Molding - Scratch &amp; Dent - Minimal / (L) Front Fender, Molding - Scratch - Minimal / (R) Front Door, Molding - Repair mark - Yes / (R) Rear Door, Molding - Repair mark - Yes / (R) Rear Fender, Molding - Repair mark - Yes / Bonnet, Headlight - Scratch &amp; Dent - Minimal / Front Bumper, Grille, Lamps - Scratch - Large / Roof - Scratch - Minimal</p>

<p><b>Inspector Notes</b></p>
<p>With Lto plate, with spare tire and jack, 1key, no warranty booklet and tools, scratches on headlights and taillights, issue on rear wiper,battery weak, fog light cover partially missing</p>
