General Information

Make	Toyota	Model	Hilux
YOM	2021	Odo Meter Reading	192,622
Registration No.	NEO2138	Chassis No.	MR0JB8DDM318094
CC	2.4	Transmission	A/T
Fuel Type	Diesel	Type of Body	Pickup
Colour	Orange

Body / Panel Condition

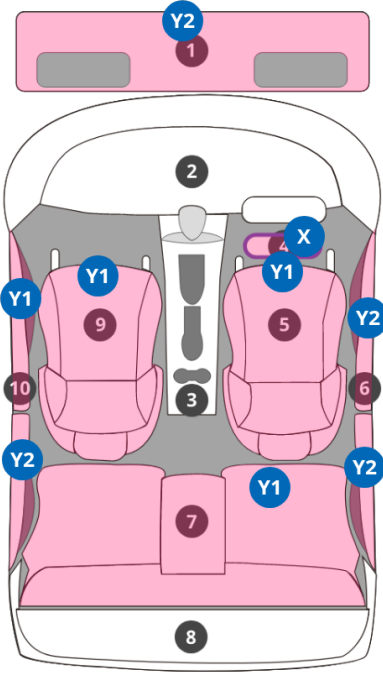
Interior Evaluation : B	Exterior Evaluation : E

<p>a : Cut, Fray d : Loose, Deformed k : Animal Hair s : Smell t : Cigarette Burns x : Defective y : Stain</p>

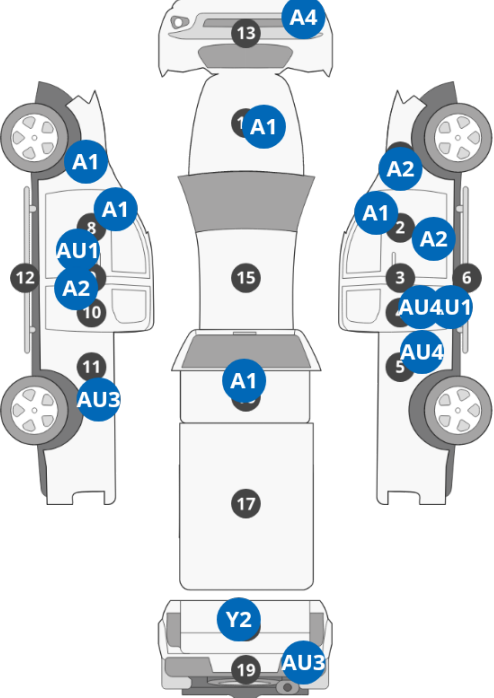
<p>A : Scratch AU : Scratch & Dent B : Modified C : Corrosion G : Stone chip P : Faded S : Rust SC : Rust & Corrosion U : Dent X : Defective Y : Crack, Gap</p>
<p>Remarks Ceiling - Grime - Small / (L) Front Seat - Grime - Minimal / (R) Front Seat - Grime - Minimal / Rear Seat - Grime - Minimal / (R) Front Trim - Grime - Small / (L) Front Trim - Grime - Minimal / (R) Rear Trim - Grime - Small / (L) Rear Trim - Grime - Small / Mat Other - Missing - Yes</p>	<p>Remarks (R) Front Fender, Molding - Scratch - Small / (R) Mirror - Scratch - Minimal / (R) Front Door, Molding - Scratch - Small / (R) Step, In-panel, Side Spoiler - Scratch & Dent - Minimal / (R) Rear Door, Molding - Scratch & Dent - Large / (R) Side Gate - Scratch & Dent - Large / Rear Bumper, Lamps, Panels - Scratch & Dent - Medium / Rear Gate - Crack, Gap - Small / (L) Side Gate - Scratch & Dent - Medium / (L) Front Door, Molding - Scratch & Dent - Minimal / (L) Rear Door, Molding - Scratch - Small / (L) Mirror - Scratch - Minimal / (L) Front Fender, Molding - Scratch - Minimal / Front Bumper, Grille, Lamps - Scratch - Large / Roof - Scratch - Minimal / Bonnet, Headlight - Scratch - Minimal</p>

<p>Inspector Notes</p>
<p>With Lto plate, with spare tire, 1key, no warranty booklet, no jack and tools, scratches on headlights and taillights</p>
