General Information

Make	Toyota	Model	Hilux Tamaraw
YOM	2025	Odo Meter Reading	29,239
Registration No.	NKS2801	Chassis No.	PAHACACA4S6426141
CC	2.4	Transmission	M/T
Fuel Type	Diesel	Type of Body	Utility Vehicle
Colour	White

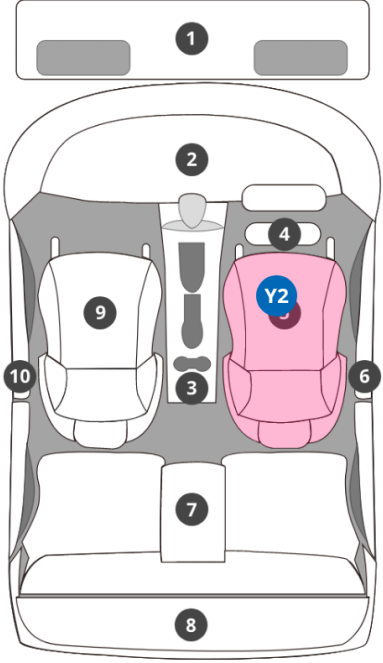
Interior Evaluation : A	Exterior Evaluation : B

<p>a : Cut, Fray d : Loose, Deformed k : Animal Hair s : Smell t : Cigarette Burns x : Defective y : Stain</p>

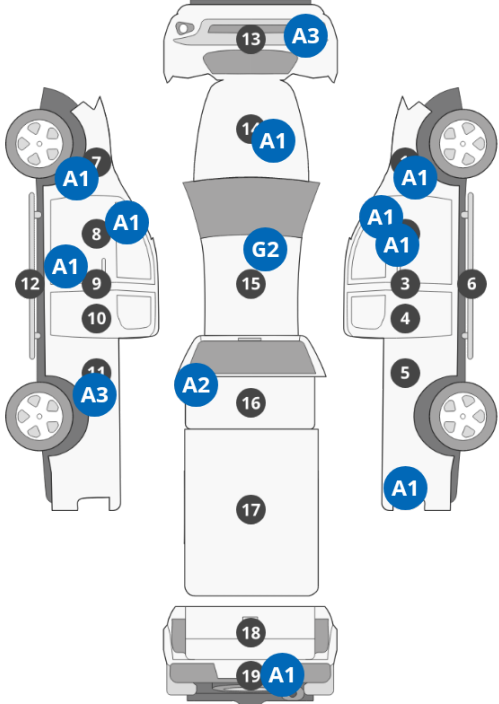
<p>A : Scratch AU : Scratch & Dent B : Modified C : Corrosion G : Stone chip P : Faded S : Rust SC : Rust & Corrosion U : Dent X : Defective Y : Crack, Gap</p>
Remarks (R) Front Seat - Grime - Small	Remarks (R) Front Fender, Molding - Scratch - Minimal / (R) Mirror - Scratch - Minimal / (R) Front Door, Molding - Scratch - Minimal / (R) Side Gate - Scratch - Minimal / Rear Bumper, Lamps, Panels - Scratch - Minimal / (L) Side Gate - Scratch - Medium / Roof - Scratch - Small / (L) Front Door, Molding - Scratch - Minimal / (L) Mirror - Scratch - Minimal / (L) Front Fender, Molding - Scratch - Minimal / Front Bumper, Grille, Lamps - Scratch - Medium / Bonnet, Headlight - Scratch - Minimal / Front Windshield - Scratch, Stone chip - Small

Inspector Notes
With Lto plate, with warranty booklet, with spare tire and jack, 2keys, no tools, scratches on headlights
