General Information

Make	Toyota	Model	Hilux Tamaraw
YOM	2025	Odo Meter Reading	2,328
Registration No.	NKS6716	Chassis No.	PAHAD9DA6S1627997
CC	2.4	Transmission	A/T
Fuel Type	Diesel	Type of Body	Dropside
Colour	Black

Body / Panel Condition

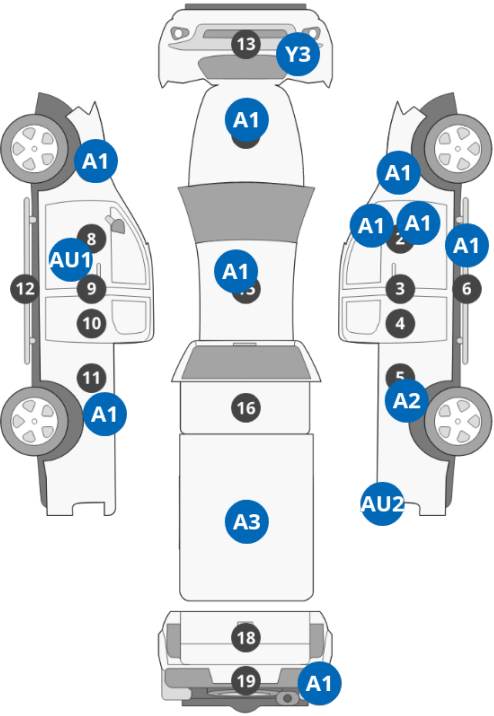
<p>A : Scratch AU : Scratch & Dent B : Modified C : Corrosion G : Stone chip P : Faded S : Rust SC : Rust & Corrosion U : Dent X : Defective Y : Crack, Gap</p>
<p>Remarks Defects not found</p>	<p>Remarks (R) Front Fender, Molding - Scratch - Minimal / (R) Mirror - Scratch - Minimal / (R) Front Door, Molding - Scratch - Minimal / (R) Step, In-panel, Side Spoiler - Scratch - Minimal / (R) Guard Frame - Scratch - Small / (R) Side Gate - Scratch & Dent - Small / Rear Bumper, Lamps, Panels - Scratch - Minimal / (L) Side Gate - Scratch - Minimal / Cargo Bed Floor - Scratch - Medium / (L) Front Door, Molding - Scratch & Dent - Minimal / (L) Front Fender, Molding - Scratch - Minimal / Bonnet, Headlight - Scratch - Minimal / Roof - Scratch - Minimal / Front Bumper, Grille, Lamps - Crack, Gap - Medium</p>

<p>Inspector Notes</p>
<p>With Lto plate, with warranty booklet, with spare tire and jack, 2keys, no tools, Crack headlight, scratches on taillights,</p>
