General Information

Make	Toyota	Model	Vios
YOM	2021	Odo Meter Reading	25,439
Registration No.	NGO1662	Chassis No.	PA1B18F30L4121876
CC	1.3	Transmission	CVT
Fuel Type	Gas	Type of Body	Sedan
Colour	Red Mica Metallic

Body / Panel Condition

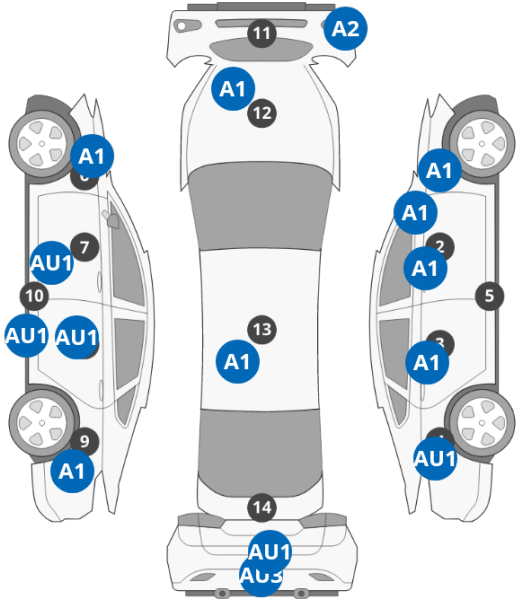
<p>A : Scratch AU : Scratch & Dent B : Modified C : Corrosion G : Stone chip P : Faded S : Rust SC : Rust & Corrosion U : Dent X : Defective Y : Crack, Gap</p>
Remarks Defects not found	Remarks (L) Front Door - Repair Traces - Yes / (L) Rear Door - Repair Traces - Yes / (R) Front Fender, Molding - Scratch - Minimal / (R) Mirror - Scratch - Minimal / (R) Front Door, Molding - Scratch - Minimal / (R) Rear Door, Molding - Scratch - Minimal / (R) Rear Fender, Molding - Scratch & Dent - Minimal / Rear Bumper, Lamps, Panels - Scratch & Dent - Medium / Trunk Hood, Rear Gate - Scratch & Dent - Minimal / (L) Rear Fender, Molding - Scratch - Minimal / (L) Rear Door, Molding - Scratch & Dent - Minimal / (L) Step, In-panel, Side Spoiler - Scratch & Dent - Minimal / (L) Front Door, Molding - Scratch & Dent - Minimal / (L) Front Fender, Molding - Scratch - Minimal / Bonnet, Headlight - Scratch - Minimal / Front Bumper, Grille, Lamps - Scratch - Small / Roof - Scratch - Minimal

With Lto plate, with spare tire and jack, 1key, no warranty booklet and tools, scratches on headlights, Crack taillight,
