General Information

Make	Toyota	Model	Vios
YOM	2025	Odo Meter Reading	24,618
Registration No.	CCG2760	Chassis No.	PA1B18F37S4282143
CC	1.3	Transmission	CVT
Fuel Type	Gas	Type of Body	Sedan
Colour	Silver

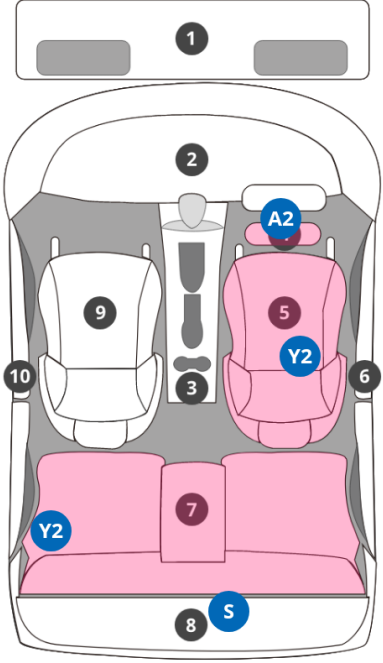
<p>a : Cut, Fray d : Loose, Deformed k : Animal Hair s : Smell t : Cigarette Burns x : Defective y : Stain</p>

<p>A : Scratch AU : Scratch & Dent B : Modified C : Corrosion G : Stone chip P : Faded S : Rust SC : Rust & Corrosion U : Dent X : Defective Y : Crack, Gap</p>
<p>Remarks Overall Interior - Smell - Yes / (L) Front Floor Mat - Cut, Crack - Small / (R) Front Seat - Grime - Small / Rear Seat - Grime - Small</p>	<p>Remarks (R) Front Fender, Molding - Scratch - Minimal / (R) Mirror - Scratch - Minimal / (R) Front Door, Molding - Scratch - Minimal / (R) Step, In-panel, Side Spoiler - Scratch - Minimal / (R) Rear Door, Molding - Scratch & Dent - Medium / (R) Rear Fender, Molding - Scratch - Minimal / Rear Bumper, Lamps, Panels - Scratch - Minimal / Trunk Hood, Rear Gate - Scratch - Minimal / (L) Rear Fender, Molding - Scratch - Small / (L) Rear Door, Molding - Scratch & Dent - Minimal / (L) Front Door, Molding - Scratch - Minimal / (L) Front Fender, Molding - Scratch - Minimal / Front Bumper, Grille, Lamps - Scratch - Minimal / Bonnet, Headlight - Scratch - Minimal</p>
