General Information

Make	Toyota	Model	Vios
YOM	2025	Odo Meter Reading	17,051
Registration No.	NHH2452	Chassis No.	PA1B18F37R4274148
CC	1.3	Transmission	CVT
Fuel Type	Gas	Type of Body	Sedan
Colour	Blackish Red Mica

Body / Panel Condition

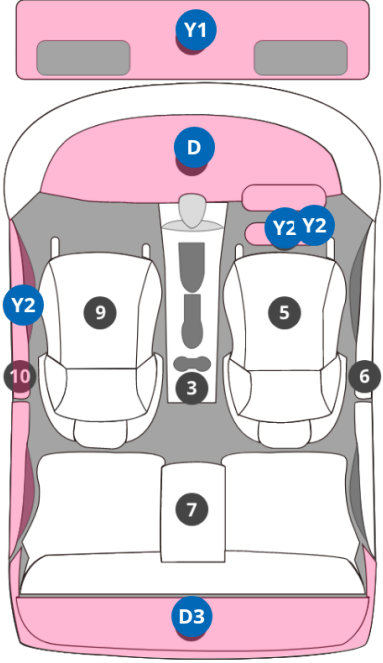
Interior Evaluation : B	Exterior Evaluation : C

<p>a : Cut, Fray d : Loose, Deformed k : Animal Hair s : Smell t : Cigarette Burns x : Defective y : Stain</p>

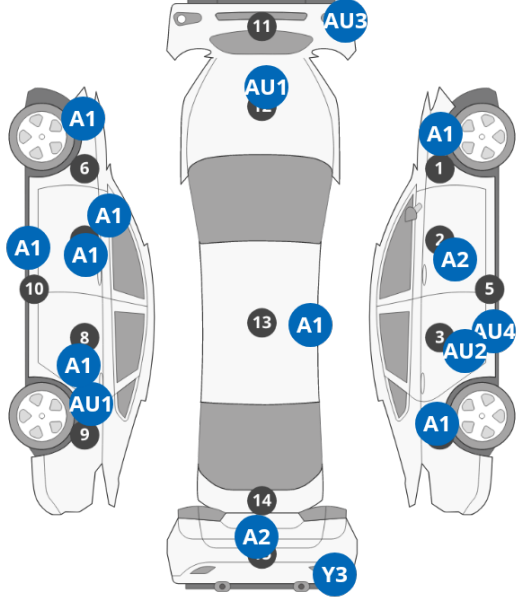
<p>A : Scratch AU : Scratch & Dent B : Modified C : Corrosion G : Stone chip P : Faded S : Rust SC : Rust & Corrosion U : Dent X : Defective Y : Crack, Gap</p>
<p>Remarks Ceiling - Grime - Minimal / Trunk Room - Loose, Deformed - Medium / (L) Front Trim - Grime - Small / (L) Front Floor Mat - Grime - Small / (R) Front Floor Mat - Grime - Small / Dashboard - Traces of Adhesive Tape - Yes</p>	<p>Remarks (R) Front Fender, Molding - Scratch - Minimal / (R) Front Door, Molding - Scratch - Small / (R) Step, In-panel, Side Spoiler - Scratch & Dent - Large / (R) Rear Door, Molding - Scratch & Dent - Small / (R) Rear Fender, Molding - Scratch - Minimal / Roof - Scratch - Minimal / Trunk Hood, Rear Gate - Scratch - Small / Rear Bumper, Lamps, Panels - Crack, Gap - Medium / (L) Rear Fender, Molding - Scratch & Dent - Minimal / (L) Rear Door, Molding - Scratch - Minimal / (L) Step, In-panel, Side Spoiler - Scratch - Minimal / (L) Front Door, Molding - Scratch - Minimal / (L) Mirror - Scratch - Minimal / (L) Front Fender, Molding - Scratch - Minimal / Front Bumper, Grille, Lamps - Scratch & Dent - Medium / Bonnet, Headlight - Scratch & Dent - Minimal</p>
