General Information

Make	Toyota	Model	Vios
YOM	2024	Odo Meter Reading	11,415
Registration No.	NEY3200	Chassis No.	PA1B18F32R4254101
CC	1.3	Transmission	CVT
Fuel Type	Gas	Type of Body	Sedan
Colour	Silver

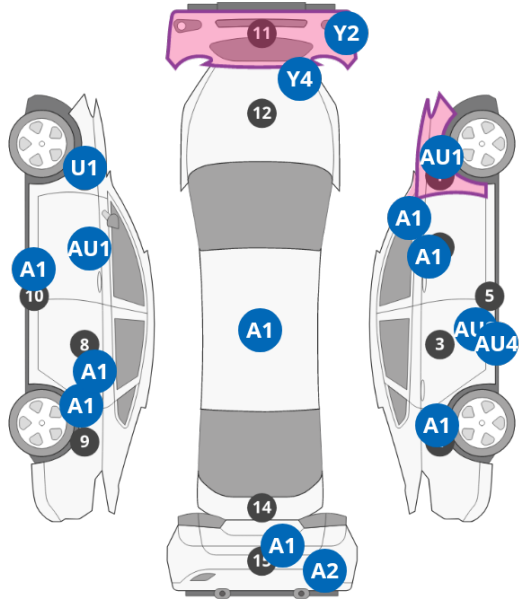
<p>A : Scratch AU : Scratch & Dent B : Modified C : Corrosion G : Stone chip P : Faded S : Rust SC : Rust & Corrosion U : Dent X : Defective Y : Crack, Gap</p>
Remarks Defects not found	Remarks (R) Front Fender - Repair Traces - Yes / Trunk Hood, Rear Gate - Repair Traces - Yes / (R) Front Fender, Molding - Repair mark - Yes / (R) Front Fender, Molding - Scratch & Dent - Minimal / (R) Mirror - Scratch - Minimal / (R) Front Door, Molding - Scratch - Minimal / (R) Rear Door, Molding - Scratch & Dent - Small / (R) Step, In-panel, Side Spoiler - Scratch & Dent - Large / Roof - Scratch - Minimal / (R) Rear Fender, Molding - Scratch - Minimal / Trunk Hood, Rear Gate - Scratch - Minimal / Rear Bumper, Lamps, Panels - Scratch - Small / (L) Rear Fender, Molding - Scratch - Minimal / (L) Rear Door, Molding - Scratch - Minimal / (L) Step, In-panel, Side Spoiler - Scratch - Minimal / (L) Front Door, Molding - Scratch & Dent - Minimal / (L) Front Fender, Molding - Dent - Minimal / Bonnet, Headlight - Crack, Gap - Large / Front Bumper, Grille, Lamps - Repair mark - Yes / Front Bumper, Grille, Lamps - Crack, Gap - Small

Inspector Notes
With Lto plate, with spare tire, 1key, no warranty booklet, no jack and tools, Crack headlight, scratches on taillights,
