General Information

Body / Panel Condition

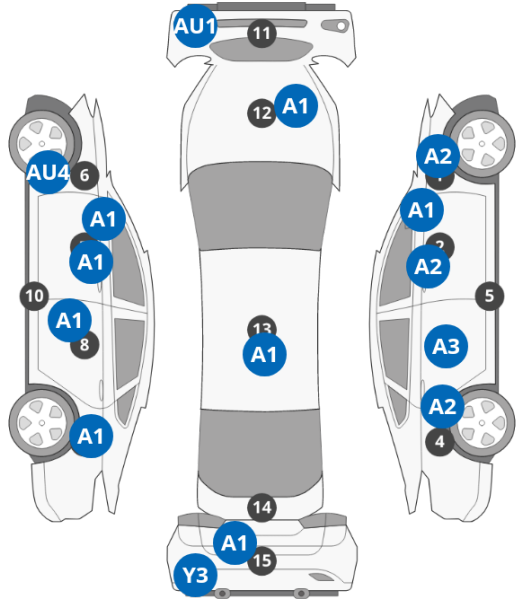
<p>A : Scratch AU : Scratch & Dent B : Modified C : Corrosion G : Stone chip P : Faded S : Rust SC : Rust & Corrosion U : Dent X : Defective Y : Crack, Gap</p>
<p>Remarks Defects not found</p>	<p>Remarks (L) Front Fender - Repair Traces - Yes / (R) Front Fender, Molding - Scratch - Small / (R) Front Door, Molding - Scratch - Small / (R) Mirror - Scratch - Minimal / Roof - Scratch - Minimal / (R) Rear Door, Molding - Scratch - Medium / (R) Rear Fender, Molding - Scratch - Small / Trunk Hood, Rear Gate - Scratch - Minimal / Rear Bumper, Lamps, Panels - Crack, Gap - Medium / (L) Rear Fender, Molding - Scratch - Minimal / (L) Rear Door, Molding - Scratch - Minimal / (L) Front Door, Molding - Scratch - Minimal / (L) Front Fender, Molding - Scratch & Dent - Large / Bonnet, Headlight - Scratch - Minimal / (L) Mirror - Scratch - Minimal / Front Bumper, Grille, Lamps - Scratch & Dent - Minimal</p>
