## General Information

<b>Make</b>	Toyota	<b>Model</b>	Wigo
<b>YOM</b>	2021	<b>Odo Meter Reading</b>	55,148
<b>Registration No.</b>	NEF9287	<b>Chassis No.</b>	MHKA4DF5FMJ053197
<b>CC</b>	1.0	<b>Transmission</b>	A/T
<b>Fuel Type</b>	Gas	<b>Type of Body</b>	Hatchback
<b>Colour</b>	Gray

## Body / Panel Condition

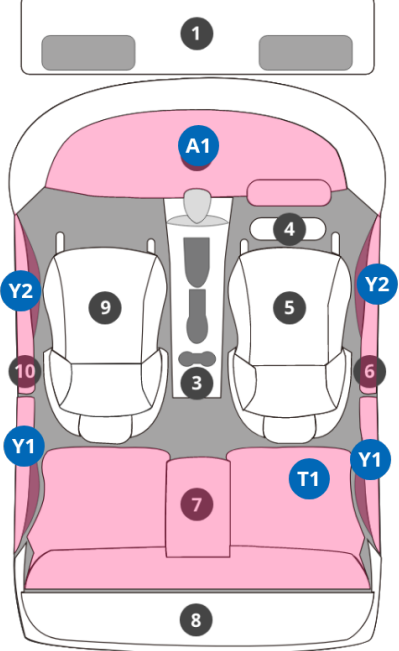
<b>Interior Evaluation :</b> <span style="float: right; color: red; font-weight: bold;">A</span>	<b>Exterior Evaluation :</b> <span style="float: right; color: red; font-weight: bold;">E</span>

<p><b>a</b> : Cut, Fray <b>d</b> : Loose, Deformed <b>k</b> : Animal Hair <b>s</b> : Smell <b>t</b> : Cigarette Burns <b>x</b> : Defective <b>y</b> : Stain</p>

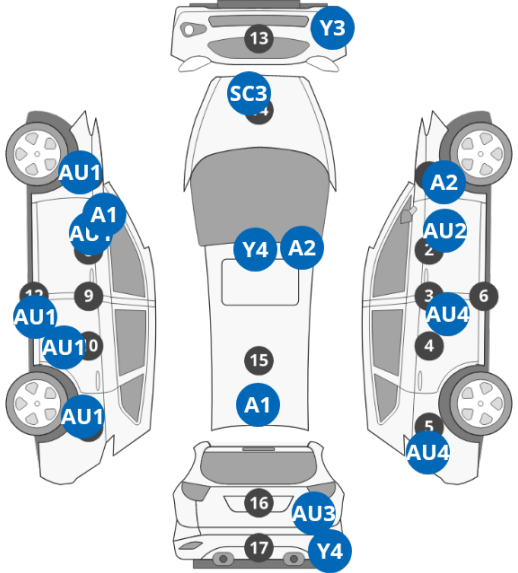
<p><b>A</b> : Scratch <b>AU</b> : Scratch &amp; Dent <b>B</b> : Modified <b>C</b> : Corrosion <b>G</b> : Stone chip <b>P</b> : Faded <b>S</b> : Rust <b>SC</b> : Rust &amp; Corrosion <b>U</b> : Dent <b>X</b> : Defective <b>Y</b> : Crack, Gap</p>
<p><b>Remarks</b> (L) Front Trim - Grime - Small / (R) Front Trim - Grime - Small / Rear Seat - Cigarette Burns - Burnt Minimal / (R) Rear Trim - Grime - Minimal / (L) Rear Trim - Grime - Minimal / Dashboard - Worn, Scratch, Cut, Crack - Minimal</p>	<p><b>Remarks</b> (R) Front Fender, Molding - Scratch - Small / Roof - Scratch - Small / (R) Front Door, Molding - Scratch &amp; Dent - Small / (R) Rear Door, Molding - Scratch &amp; Dent - Large / (R) Rear Fender, Molding - Scratch &amp; Dent - Large / Rear Bumper, Lamps, Panels - Crack, Gap - Large / Trunk Hood, Rear Gate - Scratch &amp; Dent - Medium / Roof Spoiler, Molding - Scratch - Minimal / (L) Rear Fender, Molding - Scratch &amp; Dent - Minimal / (L) Rear Door, Molding - Scratch &amp; Dent - Minimal / (L) Step, In-panel, Side Spoiler - Scratch &amp; Dent - Minimal / (L) Front Door, Molding - Scratch &amp; Dent - Minimal / (L) Mirror - Scratch - Minimal / (L) Front Fender, Molding - Scratch &amp; Dent - Minimal / Bonnet, Headlight - Rust, Corrosion - Medium / Front Bumper, Grille, Lamps - Crack, Gap - Medium / Front Windshield - Damaged - Large</p>

With Lto plate, with warranty booklet, with spare tire and jack, 1key, no tools, scratches on headlights, Crack taillight and windshield, warning lamp on, battery weak
