## General Information

<b>Make</b>	Toyota	<b>Model</b>	Rush
<b>YOM</b>	2022	<b>Odo Meter Reading</b>	31,763
<b>Registration No.</b>	NFD1901	<b>Chassis No.</b>	MHKE8FF3MK38426
<b>CC</b>	1.5	<b>Transmission</b>	A/T
<b>Fuel Type</b>	Gas	<b>Type of Body</b>	SUV
<b>Colour</b>	White

## Body / Panel Condition

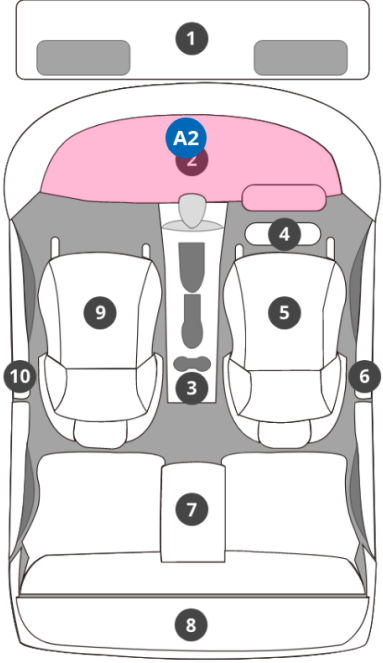
<b>Interior Evaluation :</b> <span style="color: red; font-size: 24px; font-weight: bold;">A</span>	<b>Exterior Evaluation :</b> <span style="color: red; font-size: 24px; font-weight: bold;">C</span>

<p><b>a</b> : Cut, Fray <b>d</b> : Loose, Deformed <b>k</b> : Animal Hair <b>s</b> : Smell <b>t</b> : Cigarette Burns <b>x</b> : Defective <b>y</b> : Stain</p>

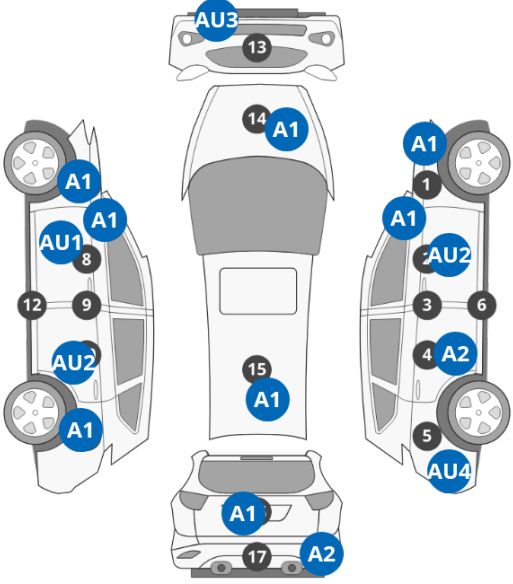
<p><b>A</b> : Scratch <b>AU</b> : Scratch &amp; Dent <b>B</b> : Modified <b>C</b> : Corrosion <b>G</b> : Stone chip <b>P</b> : Faded <b>S</b> : Rust <b>SC</b> : Rust &amp; Corrosion <b>U</b> : Dent <b>X</b> : Defective <b>Y</b> : Crack, Gap</p>
<p><b>Remarks</b> Steering Wheel - Worn, Peel, Crack - Small</p>	<p><b>Remarks</b> (R) Front Fender, Molding - Scratch - Minimal / (R) Mirror - Scratch - Minimal / (R) Front Door, Molding - Scratch &amp; Dent - Small / (R) Rear Door, Molding - Scratch - Small / (R) Rear Fender, Molding - Scratch &amp; Dent - Large / Rear Bumper, Lamps, Panels - Scratch - Small / Trunk Hood, Rear Gate - Scratch - Minimal / (L) Rear Fender, Molding - Scratch - Minimal / (L) Rear Door, Molding - Scratch &amp; Dent - Small / Roof Spoiler, Molding - Scratch - Minimal / (L) Front Door, Molding - Scratch &amp; Dent - Minimal / (L) Mirror - Scratch - Minimal / (L) Front Fender, Molding - Scratch - Minimal / Front Bumper, Grille, Lamps - Scratch &amp; Dent - Medium / Bonnet, Headlight - Scratch - Minimal</p>

<p><b>Inspector Notes</b></p>
<p>With Lto plate, with warranty booklet, with spare tire and jack, 1key, no tools, scratches on headlights and taillights</p>
