General Information

Make	Toyota	Model	Vios
YOM	2022	Odo Meter Reading	52,212
Registration No.	CAX9115	Chassis No.	PA1B18F3XN4175110
CC	1.3	Transmission	CVT
Fuel Type	Gas	Type of Body	Sedan
Colour	Black

Body / Panel Condition

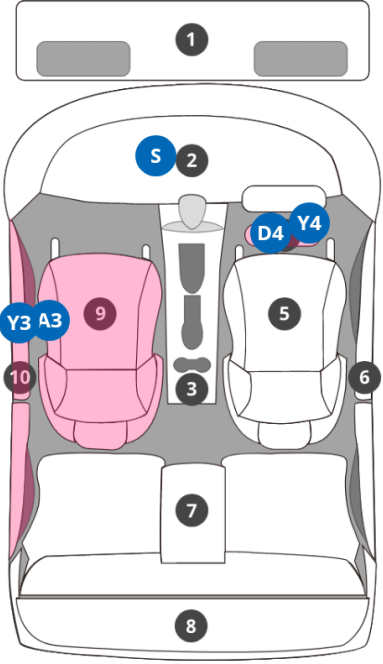
Interior Evaluation : C	Exterior Evaluation : E

<p>a : Cut, Fray d : Loose, Deformed k : Animal Hair s : Smell t : Cigarette Burns x : Defective y : Stain</p>

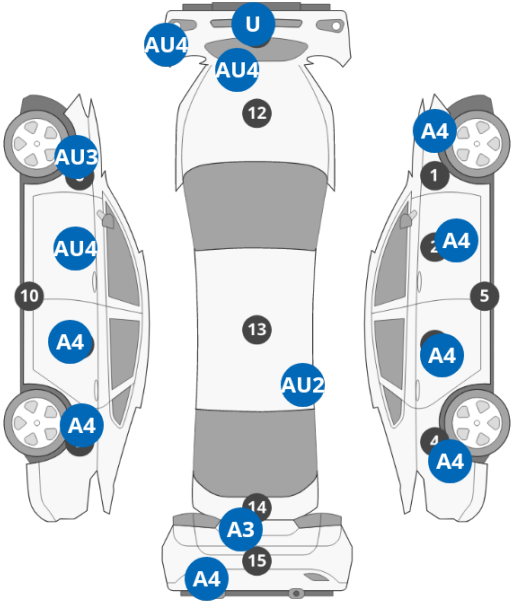
<p>A : Scratch AU : Scratch & Dent B : Modified C : Corrosion G : Stone chip P : Faded S : Rust SC : Rust & Corrosion U : Dent X : Defective Y : Crack, Gap</p>
<p>Remarks (L) Front Floor Mat - Worked - Large / (L) Front Seat - Cut, Crack - Medium / (L) Front Trim - Grime - Medium / (R) Front Floor Mat - Grime - Large / Overall Interior - Smell - Yes</p>	<p>Remarks (R) Front Door - Repair Traces - Yes / (R) Step - Repair Traces - Yes / (L) Front Fender, Molding - Scratch & Dent - Medium / Bonnet, Headlight - Scratch & Dent - Large / Member (Bolted) - Dent - Yes / Front Bumper, Grille, Lamps - Scratch & Dent - Large / (L) Front Door, Molding - Scratch & Dent - Large / (L) Rear Door, Molding - Scratch - Large / (L) Rear Fender, Molding - Scratch - Large / Rear Bumper, Lamps, Panels - Scratch - Large / Trunk Hood, Rear Gate - Scratch - Medium / (R) Rear Fender, Molding - Scratch - Large / (R) Rear Door, Molding - Scratch - Large / (R) Front Door, Molding - Scratch - Large / (R) Front Fender, Molding - Scratch - Large / Roof - Scratch & Dent - Small</p>
