General Information

Make	Toyota	Model	Vios
YOM	2024	Odo Meter Reading	30,975
Registration No.	NFR9020	Chassis No.	PA1B18F38R4259142
CC	1.3	Transmission	CVT
Fuel Type	Gas	Type of Body	Sedan
Colour	Black

Body / Panel Condition

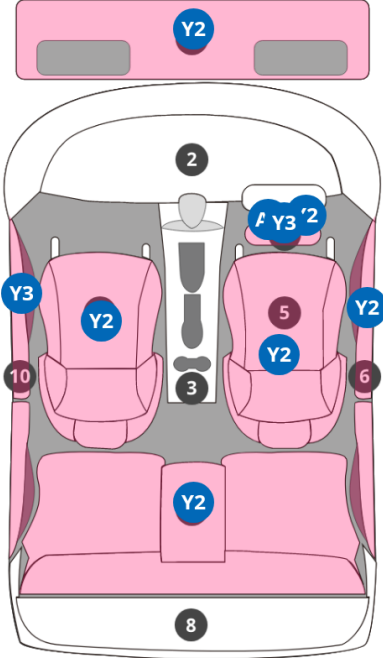
Interior Evaluation : C	Exterior Evaluation : E

<p>a : Cut, Fray d : Loose, Deformed k : Animal Hair s : Smell t : Cigarette Burns x : Defective y : Stain</p>

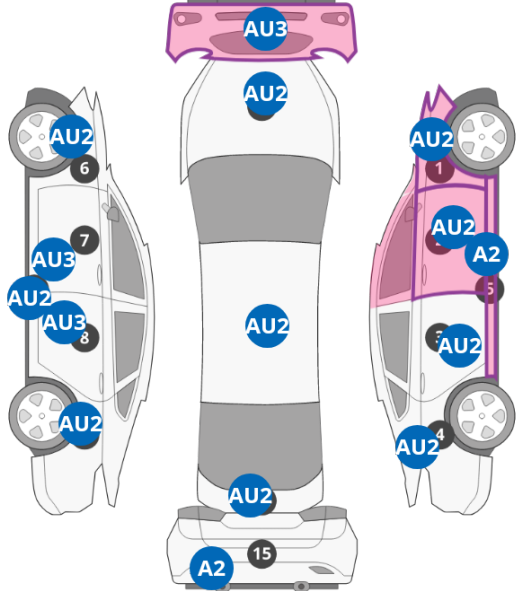
<p>A : Scratch AU : Scratch & Dent B : Modified C : Corrosion G : Stone chip P : Faded S : Rust SC : Rust & Corrosion U : Dent X : Defective Y : Crack, Gap</p>
<p>Remarks (L) Front Floor Mat - Cut, Crack - Medium / (L) Front Trim - Grime - Medium / (R) Front Floor Mat - Grime - Small / Mat Other - Grime - Medium / (L) Front Seat - Grime - Small / (R) Front Seat - Grime - Small / Rear Seat - Grime - Small / (R) Front Trim - Grime - Small / Ceiling - Grime - Small</p>	<p>Remarks (R) Front Fender - Repair Traces - Yes / (L) Front Fender - Repair Traces - Yes / (R) Rear Door - Repair Traces - Yes / Roof - Scratch & Dent - Small / (L) Front Door, Molding - Scratch & Dent - Medium / (L) Rear Door, Molding - Scratch & Dent - Medium / (L) Rear Fender, Molding - Scratch & Dent - Small / Bonnet, Headlight - Scratch & Dent - Small / Front Bumper, Grille, Lamps - Repair mark - Yes / Front Bumper, Grille, Lamps - Scratch & Dent - Medium / (R) Front Fender, Molding - Scratch & Dent - Small / (R) Front Fender, Molding - Repair mark - Yes / (R) Front Door, Molding - Repair mark - Yes / (R) Front Door, Molding - Scratch & Dent - Small / (R) Rear Door, Molding - Scratch & Dent - Small / (R) Step, In-panel, Side Spoiler - Scratch - Small / (R) Step, In-panel, Side Spoiler - Repair mark - Yes / (R) Rear Fender, Molding - Scratch & Dent - Small / Trunk Hood, Rear Gate - Scratch & Dent - Small / Rear Bumper, Lamps, Panels - Scratch - Small / (L) Step, In-panel, Side Spoiler - Scratch & Dent - Small / (L) Front Fender, Molding - Scratch & Dent - Small</p>
