General Information

Make	Toyota	Model	Hiace
YOM	2022	Odo Meter Reading	257,356
Registration No.	GAW3465	Chassis No.	JTFNAFAP7M8022870
CC	2.8	Transmission	M/T
Fuel Type	Diesel	Type of Body	Van
Colour	Black

Body / Panel Condition

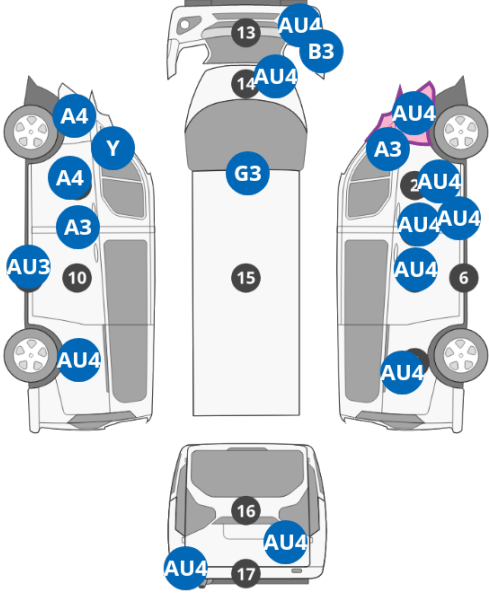
<p>A : Scratch AU : Scratch & Dent B : Modified C : Corrosion G : Stone chip P : Faded S : Rust SC : Rust & Corrosion U : Dent X : Defective Y : Crack, Gap</p>
<p>Remarks (L) Front Seat - Grime - Large / (L) Front Floor Mat - Missing - Yes / Steering Wheel - Worn, Peel, Crack - Large / Dashboard - Traces of Adhesive Tape - Yes / Console, Switches, Vents - Traces of Adhesive Tape - Yes / Sunvisor, Sunglass Holder - Grime - Large / (L) Front Trim - Grime - Small / Rear Seat - Grime - Large / Ceiling - Grime - Large / (R) Front Floor Mat - Missing - Yes / Mat Other - Missing - Yes / (R) Front Seat - Grime - Large / (R) Front Trim - Grime - Small</p>	<p>Remarks (R) Step - Repair Traces - Yes / Bonnet - Repair Traces - Yes / (L) Rear Fender - Repair Traces - Yes / Trunk Hood, Rear Gate - Repair Traces - Yes / (R) Rear Fender - Repair Traces - Yes / Roof - Repair Traces - Yes / (L) Mirror - Crack - Damaged / (L) Front Fender, Molding - Scratch - Large / (L) Front Door, Molding - Scratch - Large / (L) Center Panel - Scratch - Medium / (L) Rear Fender, Molding - Scratch & Dent - Large / (L) Step, In-panel, Side Spoiler - Scratch & Dent - Medium / Trunk Hood, Rear Gate - Scratch & Dent - Large / Rear Bumper, Lamps, Panels - Scratch & Dent - Large / (R) Rear Fender, Molding - Scratch & Dent - Large / (R) Rear Door, Molding - Scratch & Dent - Large / (R) Front Door, Molding - Scratch & Dent - Large / (R) Center Panel - Scratch & Dent - Large / (R) Step, In-panel, Side Spoiler - Scratch & Dent - Large / (R) Mirror - Scratch - Medium / (R) Front Fender, Molding - Scratch & Dent - Large / (R) Front Fender, Molding - Partially Missing - Yes / Front Bumper, Grille, Lamps - Scratch & Dent - Large / Bonnet, Headlight - Scratch & Dent - Large / Overall Exterior - Faded(Color, Gloss) - Yes / Front Bumper, Grille, Lamps - Modified - Medium / Front Windshield - Scratch, Stone chip - Medium</p>
