General Information

Make	Toyota	Model	Vios
YOM	2023	Odo Meter Reading	10,548
Registration No.	NHI8911	Chassis No.	PA1B18F35P4211157
CC	1.3	Transmission	CVT
Fuel Type	Gas	Type of Body	Sedan
Colour	Green

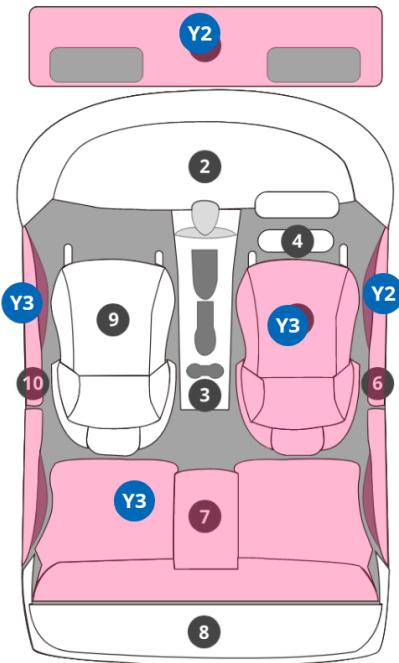
Interior Evaluation : B	Exterior Evaluation : E

<p>a : Cut, Fray d : Loose, Deformed k : Animal Hair s : Smell t : Cigarette Burns x : Defective y : Stain</p>

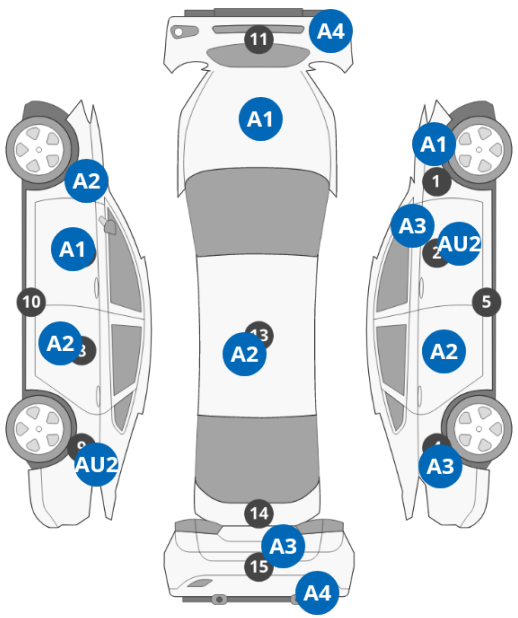
<p>A : Scratch AU : Scratch & Dent B : Modified C : Corrosion G : Stone chip P : Faded S : Rust SC : Rust & Corrosion U : Dent X : Defective Y : Crack, Gap</p>
<p>Remarks (R) Front Seat - Grime - Medium / (R) Front Trim - Grime - Small / Rear Seat - Grime - Medium / Ceiling - Grime - Small / (L) Front Trim - Grime - Medium</p>	<p>Remarks (L) Rear Fender, Molding - Scratch & Dent - Small / (L) Rear Door, Molding - Scratch - Small / (L) Front Fender, Molding - Scratch - Small / (L) Front Door, Molding - Scratch - Minimal / Roof - Scratch - Small / Front Bumper, Grille, Lamps - Scratch - Large / (R) Mirror - Scratch - Medium / (R) Front Door, Molding - Scratch & Dent - Small / (R) Front Fender, Molding - Scratch - Minimal / Bonnet, Headlight - Scratch - Minimal / (R) Rear Door, Molding - Scratch - Small / (R) Rear Fender, Molding - Scratch - Medium / Trunk Hood, Rear Gate - Scratch - Medium / Rear Bumper, Lamps, Panels - Scratch - Large</p>
