General Information

Make	Toyota	Model	Vios
YOM	2021	Odo Meter Reading	49,368
Registration No.	DAV3029	Chassis No.	PA1B18F36M4143723
CC	1.3	Transmission	CVT
Fuel Type	Gas	Type of Body	Sedan
Colour	Blue

Body / Panel Condition

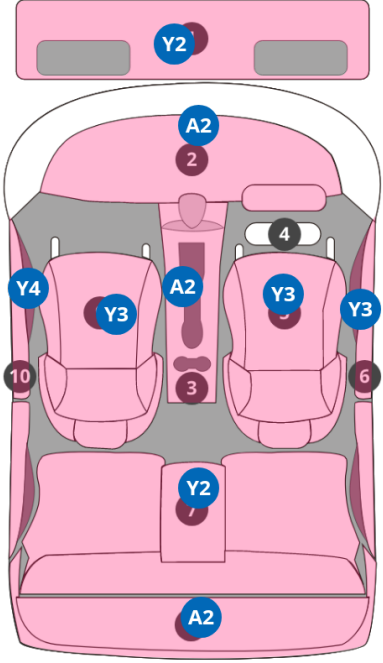
Interior Evaluation : C	Exterior Evaluation : C

<p>a : Cut, Fray d : Loose, Deformed k : Animal Hair s : Smell t : Cigarette Burns x : Defective y : Stain</p>

<p>A : Scratch AU : Scratch & Dent B : Modified C : Corrosion G : Stone chip P : Faded S : Rust SC : Rust & Corrosion U : Dent X : Defective Y : Crack, Gap</p>
Remarks (R) Front Seat - Grime - Medium / (R) Front Trim - Grime - Medium / Rear Seat - Grime - Small / Trunk Room - Worn, Scratch, Cut, Crack - Small / (L) Front Trim - Grime - Large / (L) Front Seat - Grime - Medium / Ceiling - Grime - Small / Console, Switches, Vents - Worn, Scratch, Cut, Crack - Small / Dashboard - Worn, Scratch, Cut, Crack - Small	Remarks (L) Rear Fender, Molding - Scratch - Small / (R) Rear Fender, Molding - Scratch - Medium / Trunk Hood, Rear Gate - Scratch - Small / Rear Bumper, Lamps, Panels - Scratch - Small / (L) Rear Door, Molding - Scratch - Medium / (R) Rear Door, Molding - Scratch - Small / Bonnet, Headlight - Scratch - Small / Front Bumper, Grille, Lamps - Scratch - Small / (R) Front Door, Molding - Scratch - Medium / (R) Mirror - Scratch - Minimal / Roof - Scratch - Small / (L) Front Fender, Molding - Scratch - Minimal / (L) Front Door, Molding - Scratch - Minimal
