General Information

Make	Toyota	Model	Vios
YOM	2024	Odo Meter Reading	8,390
Registration No.	DBQ9709	Chassis No.	PA1B18F32R4253725
CC	1.3	Transmission	M/T
Fuel Type	Gas	Type of Body	Sedan
Colour	Green

Body / Panel Condition

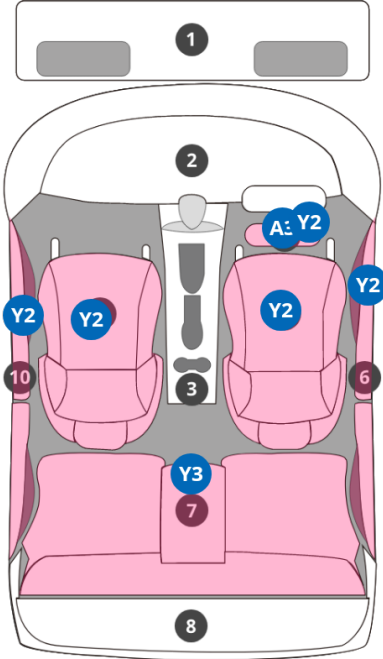
Interior Evaluation : B	Exterior Evaluation : E

<p>a : Cut, Fray d : Loose, Deformed k : Animal Hair s : Smell t : Cigarette Burns x : Defective y : Stain</p>

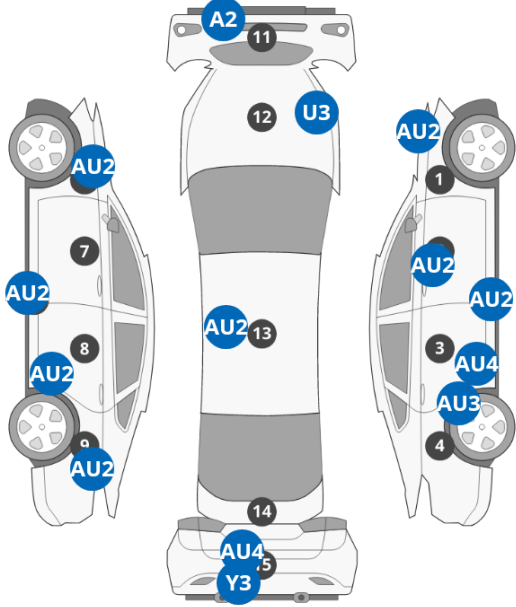
<p>A : Scratch AU : Scratch & Dent B : Modified C : Corrosion G : Stone chip P : Faded S : Rust SC : Rust & Corrosion U : Dent X : Defective Y : Crack, Gap</p>
<p>Remarks (L) Front Floor Mat - Cut, Crack - Medium / (R) Front Floor Mat - Grime - Small / (L) Front Seat - Grime - Small / (R) Front Seat - Grime - Small / (L) Front Trim - Grime - Small / (R) Front Trim - Grime - Small / Rear Seat - Grime - Medium</p>	<p>Remarks Roof - Scratch & Dent - Small / (L) Rear Door, Molding - Scratch & Dent - Small / (L) Rear Fender, Molding - Scratch & Dent - Small / Trunk Hood, Rear Gate - Scratch & Dent - Large / (R) Rear Fender, Molding - Scratch & Dent - Medium / (R) Rear Door, Molding - Scratch & Dent - Large / (R) Step, In-panel, Side Spoiler - Scratch & Dent - Small / (R) Front Door, Molding - Scratch & Dent - Small / Rear Bumper, Lamps, Panels - Crack, Gap - Medium / (R) Front Fender, Molding - Scratch & Dent - Small / Bonnet, Headlight - Dent - Medium / Front Bumper, Grille, Lamps - Scratch - Small / (L) Front Fender, Molding - Scratch & Dent - Small / (L) Step, In-panel, Side Spoiler - Scratch & Dent - Small</p>

<p>Inspector Notes</p>
<p>with LTO plate, with spare tire, with jack, with manual and warranty booklet, no spare key, no reverse camera, scratches on taillight and headlight.</p>
