General Information

Make	Toyota	Model	Vios
YOM	2025	Odo Meter Reading	31,522
Registration No.	DBR9738	Chassis No.	PA1B18F30R4280602
CC	1.3	Transmission	CVT
Fuel Type	Gas	Type of Body	Sedan
Colour	Red

Body / Panel Condition

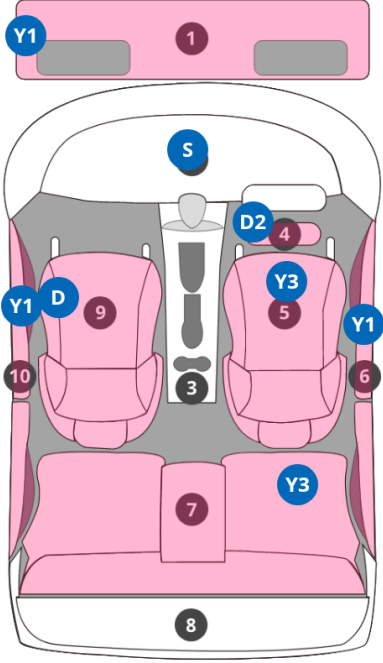
Interior Evaluation : B	Exterior Evaluation : E

<p>a : Cut, Fray d : Loose, Deformed k : Animal Hair s : Smell t : Cigarette Burns x : Defective y : Stain</p>

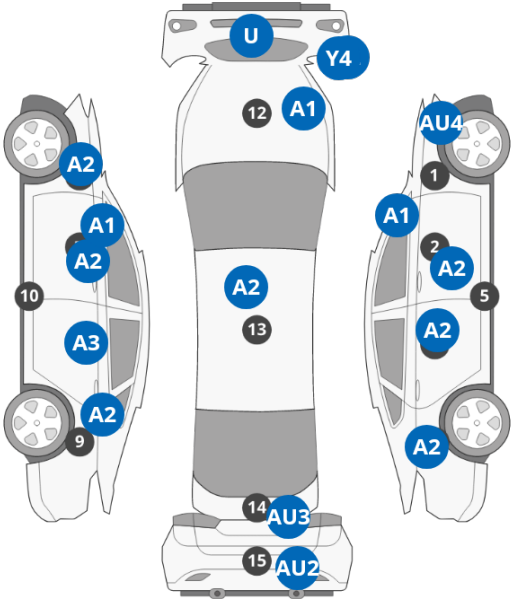
<p>A : Scratch AU : Scratch & Dent B : Modified C : Corrosion G : Stone chip P : Faded S : Rust SC : Rust & Corrosion U : Dent X : Defective Y : Crack, Gap</p>
<p>Remarks (R) Front Seat - Grime - Medium / Rear Seat - Grime - Medium / (R) Front Trim - Grime - Minimal / (L) Front Trim - Grime - Minimal / (L) Front Floor Mat - Worked - Small / (L) Front Seat - Worn - Yes / Ceiling - Grime - Minimal / Overall Interior - Smell - Yes</p>	<p>Remarks (R) Front Fender, Molding - Scratch & Dent - Large / (R) Mirror - Scratch - Minimal / (R) Front Door, Molding - Scratch - Small / (R) Rear Door, Molding - Scratch - Small / (R) Rear Fender, Molding - Scratch - Small / Rear Bumper, Lamps, Panels - Scratch & Dent - Small / Trunk Hood, Rear Gate - Scratch & Dent - Medium / (L) Rear Fender, Molding - Scratch - Small / (L) Front Door, Molding - Scratch - Small / (L) Rear Door, Molding - Scratch - Medium / (L) Mirror - Scratch - Minimal / Member (Bolted) - Dent - Yes / (L) Front Fender, Molding - Scratch - Small / Front Bumper, Grille, Lamps - Modified - Small / Front Bumper, Grille, Lamps - Crack, Gap - Large / Bonnet, Headlight - Scratch - Minimal / Roof - Scratch - Small</p>

<p>Inspector Notes</p>
<p>no warranty booklet, with jack and tools, with spare tire, with LTO plate, scratched and cracked tail light, power steering issue due to weak battery</p>
