General Information

Make	Toyota	Model	Vios
YOM	2025	Odo Meter Reading	18,540
Registration No.	DBT4642	Chassis No.	PA1B18F39S4282788
CC	1.3	Transmission	CVT
Fuel Type	Gas	Type of Body	Sedan
Colour	Silver

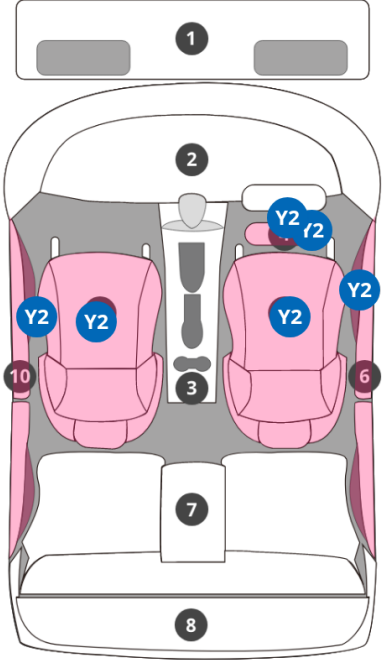
Interior Evaluation : B	Exterior Evaluation : E

<p>a : Cut, Fray d : Loose, Deformed k : Animal Hair s : Smell t : Cigarette Burns x : Defective y : Stain</p>

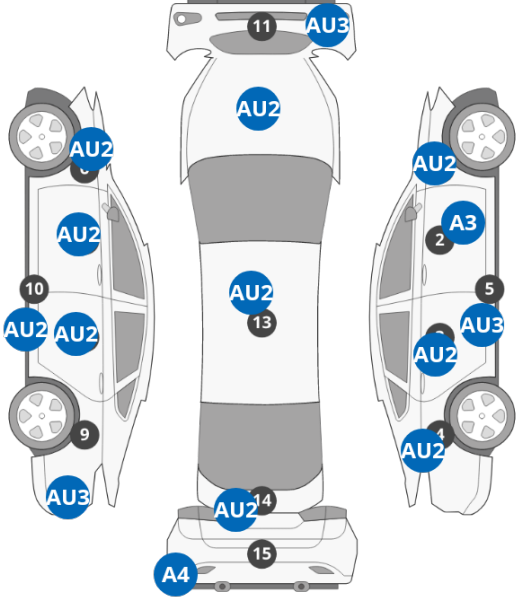
<p>A : Scratch AU : Scratch & Dent B : Modified C : Corrosion G : Stone chip P : Faded S : Rust SC : Rust & Corrosion U : Dent X : Defective Y : Crack, Gap</p>
<p>Remarks (L) Front Seat - Grime - Small / (R) Front Seat - Grime - Small / (R) Front Floor Mat - Grime - Small / (L) Front Floor Mat - Grime - Small / (L) Front Trim - Grime - Small / (R) Front Trim - Grime - Small</p>	<p>Remarks Rear Bumper, Lamps, Panels - Scratch - Large / (L) Rear Fender, Molding - Scratch & Dent - Medium / (L) Rear Door, Molding - Scratch & Dent - Small / (L) Front Door, Molding - Scratch & Dent - Small / (L) Step, In-panel, Side Spoiler - Scratch & Dent - Small / Roof - Scratch & Dent - Small / (L) Front Fender, Molding - Scratch & Dent - Small / Bonnet, Headlight - Scratch & Dent - Small / Front Bumper, Grille, Lamps - Scratch & Dent - Medium / (R) Front Fender, Molding - Scratch & Dent - Small / (R) Front Door, Molding - Scratch - Medium / (R) Step, In-panel, Side Spoiler - Scratch & Dent - Medium / (R) Rear Door, Molding - Scratch & Dent - Small / (R) Rear Fender, Molding - Scratch & Dent - Small / Trunk Hood, Rear Gate - Scratch & Dent - Small</p>
