General Information

Make	Toyota	Model	Wigo
YOM	2023	Odo Meter Reading	19,596
Registration No.	NFC7587	Chassis No.	MHKAA1BCXPJ001567
CC	1.0	Transmission	CVT
Fuel Type	Gas	Type of Body	Hatchback
Colour	Gray

Body / Panel Condition

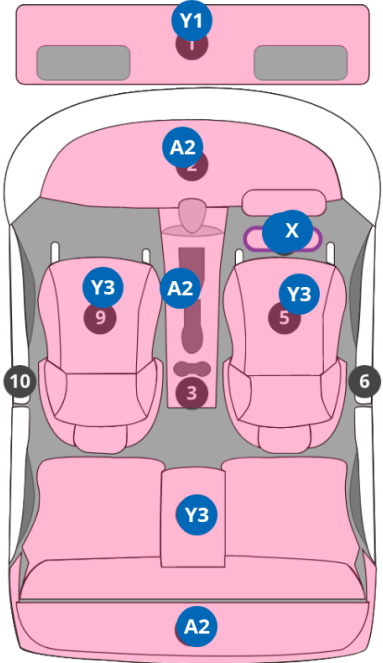
Interior Evaluation : C	Exterior Evaluation : E

<p>a : Cut, Fray d : Loose, Deformed k : Animal Hair s : Smell t : Cigarette Burns x : Defective y : Stain</p>

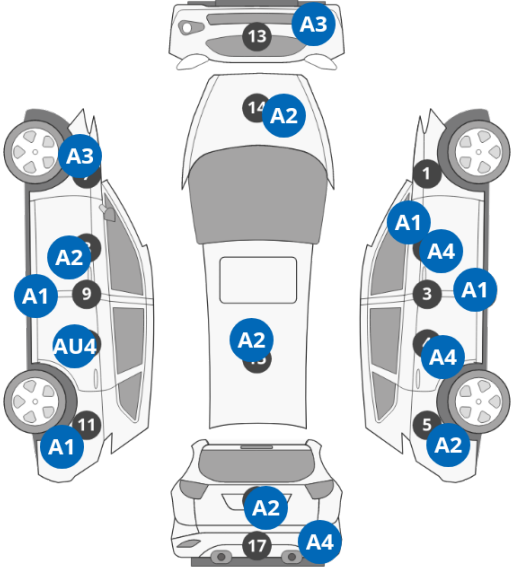
<p>A : Scratch AU : Scratch & Dent B : Modified C : Corrosion G : Stone chip P : Faded S : Rust SC : Rust & Corrosion U : Dent X : Defective Y : Crack, Gap</p>
<p>Remarks (R) Front Seat - Grime - Medium / Rear Seat - Grime - Medium / Trunk Room - Worn, Scratch, Cut, Crack - Small / (L) Front Seat - Grime - Medium / (R) Front Floor Mat - Missing - Yes / (L) Front Floor Mat - Missing - Yes / Ceiling - Grime - Minimal / Console, Switches, Vents - Worn, Scratch, Cut, Crack - Small / Dashboard - Worn, Scratch, Cut, Crack - Small</p>	<p>Remarks (R) Front Door, Molding - Scratch - Large / (R) Rear Door, Molding - Scratch - Large / (R) Rear Fender, Molding - Scratch - Small / Rear Bumper, Lamps, Panels - Scratch - Large / Trunk Hood, Rear Gate - Scratch - Small / (L) Rear Fender, Molding - Scratch - Minimal / (L) Rear Door, Molding - Scratch & Dent - Large / (L) Front Door, Molding - Scratch - Small / (L) Front Fender, Molding - Scratch - Medium / (R) Mirror - Scratch - Minimal / Bonnet, Headlight - Scratch - Small / Front Bumper, Grille, Lamps - Scratch - Medium / Roof - Scratch - Small / (R) Step, In-panel, Side Spoiler - Scratch - Minimal / (L) Step, In-panel, Side Spoiler - Scratch - Minimal</p>
