General Information

Make	Toyota	Model	Vios
YOM	2024	Odo Meter Reading	15,543
Registration No.	NFR5964	Chassis No.	PA1B18F39R4253110
CC	1.3	Transmission	CVT
Fuel Type	Gas	Type of Body	Sedan
Colour	Blue

Body / Panel Condition

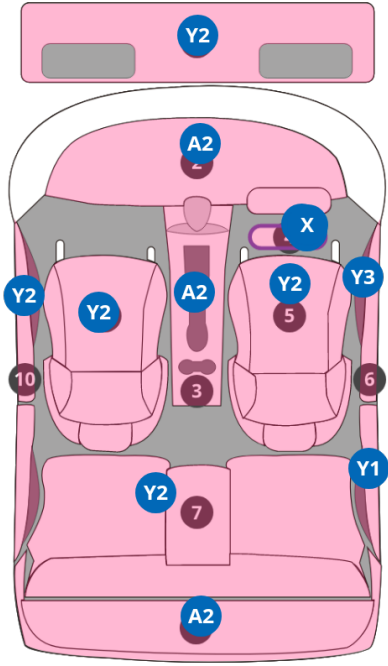
<p>a : Cut, Fray d : Loose, Deformed k : Animal Hair s : Smell t : Cigarette Burns x : Defective y : Stain</p>

<p>A : Scratch AU : Scratch & Dent B : Modified C : Corrosion G : Stone chip P : Faded S : Rust SC : Rust & Corrosion U : Dent X : Defective Y : Crack, Gap</p>
<p>Remarks Dashboard - Worn, Scratch, Cut, Crack - Small / Rear Seat - Grime - Small / (R) Front Trim - Grime - Medium / (R) Rear Trim - Grime - Minimal / (L) Front Trim - Grime - Small / Ceiling - Grime - Small / (R) Front Floor Mat - Missing - Yes / (L) Front Floor Mat - Missing - Yes / Mat Other - Missing - Yes / Trunk Room - Worn, Scratch, Cut, Crack - Small / (L) Front Seat - Grime - Small / (R) Front Seat - Grime - Small / Console, Switches, Vents - Worn, Scratch, Cut, Crack - Small</p>	<p>Remarks Trunk Hood, Rear Gate - Scratch - Small / Rear Bumper, Lamps, Panels - Scratch - Small / (R) Rear Fender, Molding - Scratch - Small / (R) Rear Door, Molding - Scratch - Small / (R) Front Door, Molding - Scratch - Small / (R) Step, In-panel, Side Spoiler - Scratch - Small / Front Bumper, Grille, Lamps - Scratch - Small / (L) Front Fender, Molding - Scratch - Minimal / (L) Mirror - Scratch - Minimal / (L) Step, In-panel, Side Spoiler - Scratch - Minimal / (L) Rear Door, Molding - Scratch - Minimal / (L) Front Door, Molding - Scratch - Minimal / (L) Rear Fender, Molding - Scratch - Small / Roof - Scratch & Dent - Small / Bonnet, Headlight - Scratch & Dent - Small</p>
