General Information

Make	Toyota	Model	Vios
YOM	2024	Odo Meter Reading	27,771
Registration No.	NFR3670	Chassis No.	PA1B18F36R4250603
CC	1.3	Transmission	CVT
Fuel Type	Gas	Type of Body	Sedan
Colour	Red

Body / Panel Condition

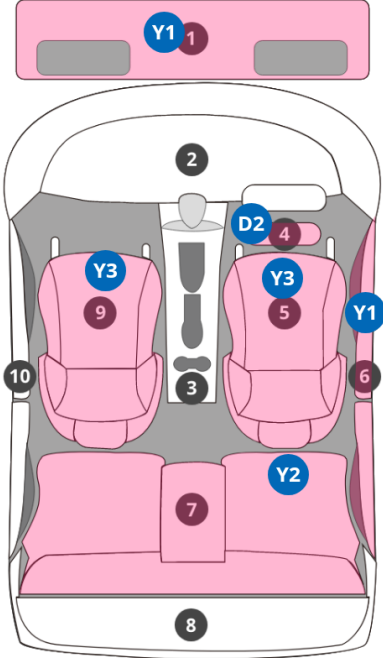
Interior Evaluation : B	Exterior Evaluation : C

<p>a : Cut, Fray d : Loose, Deformed k : Animal Hair s : Smell t : Cigarette Burns x : Defective y : Stain</p>

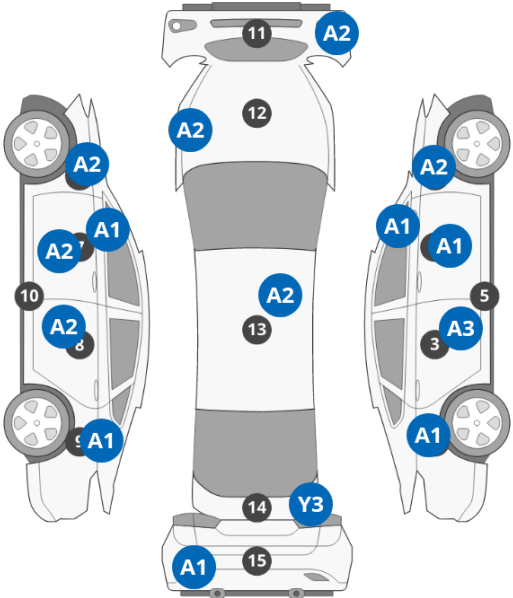
<p>A : Scratch AU : Scratch & Dent B : Modified C : Corrosion G : Stone chip P : Faded S : Rust SC : Rust & Corrosion U : Dent X : Defective Y : Crack, Gap</p>
<p>Remarks (R) Front Seat - Grime - Medium / (L) Front Seat - Grime - Medium / Ceiling - Grime - Minimal / (L) Front Floor Mat - Worked - Small / (R) Front Trim - Grime - Minimal / Rear Seat - Grime - Small</p>	<p>Remarks (R) Front Fender, Molding - Scratch - Small / (R) Mirror - Scratch - Minimal / (R) Front Door, Molding - Scratch - Minimal / (R) Rear Door, Molding - Scratch - Medium / (R) Rear Fender, Molding - Scratch - Minimal / Rear Bumper, Lamps, Panels - Scratch - Minimal / (L) Rear Fender, Molding - Scratch - Minimal / (L) Front Door, Molding - Scratch - Small / (L) Rear Door, Molding - Scratch - Small / (L) Mirror - Scratch - Minimal / (L) Front Fender, Molding - Scratch - Small / Front Bumper, Grille, Lamps - Scratch - Small / Bonnet, Headlight - Scratch - Small / Roof - Scratch - Small / Trunk Hood, Rear Gate - Crack, Gap - Medium</p>
