General Information

Make	Toyota	Model	Vios
YOM	2024	Odo Meter Reading	24,706
Registration No.	NHR9308	Chassis No.	PA1B18F33P4235473
CC	1.3	Transmission	CVT
Fuel Type	Gas	Type of Body	Sedan
Colour	Green

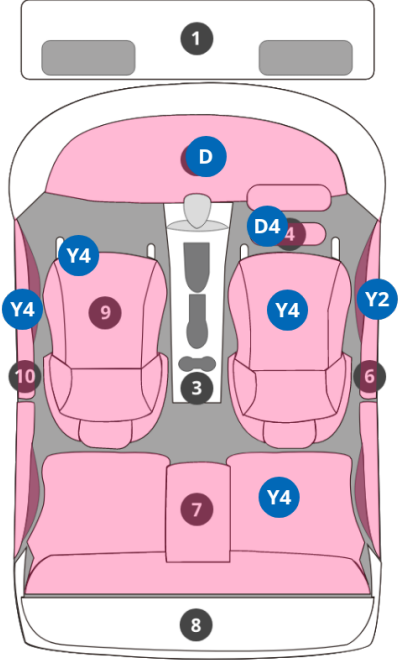
Interior Evaluation : D	Exterior Evaluation : E

<p>a : Cut, Fray d : Loose, Deformed k : Animal Hair s : Smell t : Cigarette Burns x : Defective y : Stain</p>

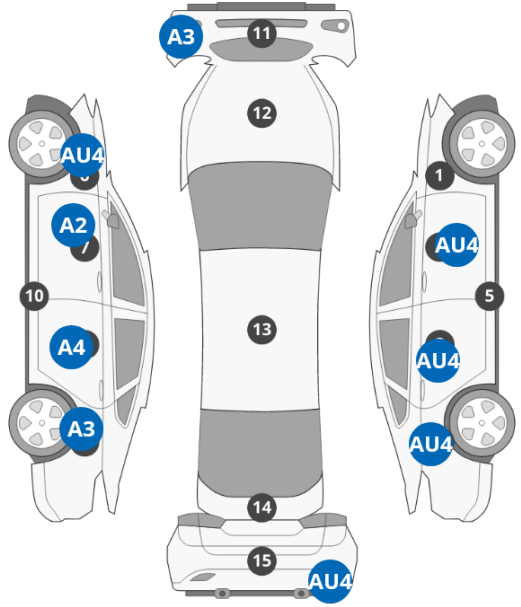
<p>A : Scratch AU : Scratch & Dent B : Modified C : Corrosion G : Stone chip P : Faded S : Rust SC : Rust & Corrosion U : Dent X : Defective Y : Crack, Gap</p>
<p>Remarks Rear Seat - Grime - Large / (R) Front Trim - Grime - Small / (R) Front Seat - Grime - Large / Dashboard - Traces of Adhesive Tape - Yes / (L) Front Seat - Grime - Large / (L) Front Trim - Grime - Large / (L) Front Floor Mat - Worked - Large</p>	<p>Remarks (R) Front Door, Molding - Scratch & Dent - Large / (R) Rear Door, Molding - Scratch & Dent - Large / (R) Rear Fender, Molding - Scratch & Dent - Large / Rear Bumper, Lamps, Panels - Scratch & Dent - Large / (L) Rear Fender, Molding - Scratch - Medium / (L) Rear Door, Molding - Scratch - Large / (L) Front Door, Molding - Scratch - Small / (L) Front Fender, Molding - Scratch & Dent - Large / Front Bumper, Grille, Lamps - Scratch - Medium</p>
