## General Information

| Make | Kia | Model | Carnival |
| YOM | 2008 | Mileage | 187,453 |

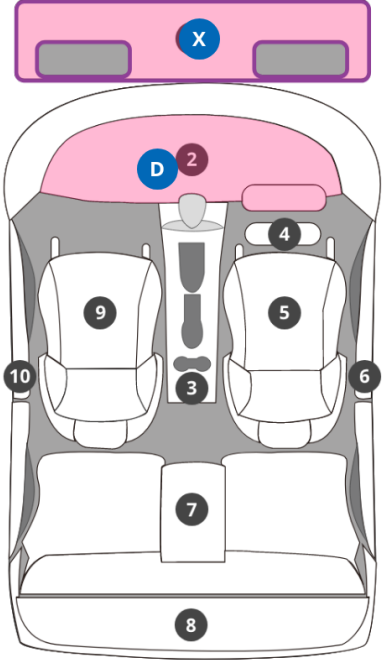
| <b>Remarks</b><br>Overall Interior - Worn as per age - Yes / Sunvisor, Sunglass Holder - Missing - Yes / Room Lamp - Partially Missing - Yes / Switchs - Missing - Yes / Dashboard - Traces of Adhesive Tape - Yes | <b>Remarks</b><br>(R) Front Door - Repair Traces - Yes / (R) Front Fender - Repair Traces - Yes / Bonnet - Repair Traces - Yes / (L) Front Fender - Repair Traces - Yes / (L) Front Door - Repair Traces - Yes / (L) Rear Door - Repair Traces - Yes / (L) Rear Fender - Repair Traces - Yes / Trunk Hood, Rear Gate - Repair Traces - Yes / (R) Rear Fender - Repair Traces - Yes / (R) Rear Door - Repair Traces - Yes / Roof - Repair Traces - Yes / Front Bumper, Grille, Lamps - Scratch & Dent - Large / (R) Front Fender, Molding - Scratch & Dent - Medium / (R) Rear Door, Molding - Scratch & Dent - Medium / (R) Rear Fender, Molding - Scratch - Medium / Rear Bumper, Lamps, Panels - Scratch & Dent - Large / (L) Rear Fender, Molding - Scratch - Medium / Roof - Dent - Small / Bonnet, Headlight - Dent - Small / (R) Mirror - Scratch, Peeled - Minimal |
