General Information

Make	Toyota	Model	Vios
YOM	2025	Odo Meter Reading	21,927
Registration No.	NJF6187	Chassis No.	PA1B18F34S4283962
CC	1.3	Transmission	CVT
Fuel Type	Gas	Type of Body	Sedan
Colour	Silver

Body / Panel Condition

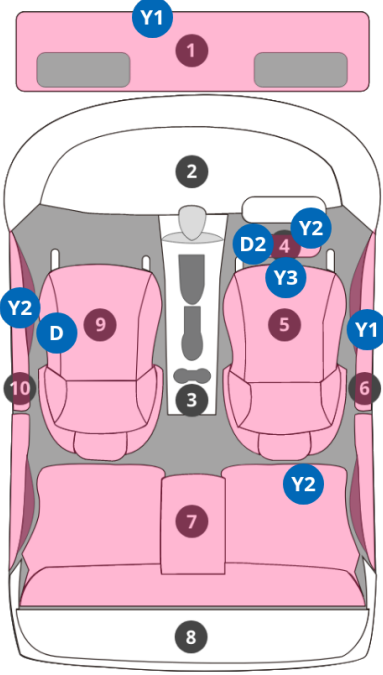
Interior Evaluation : B	Exterior Evaluation : E

<p>a : Cut, Fray d : Loose, Deformed k : Animal Hair s : Smell t : Cigarette Burns x : Defective y : Stain</p>

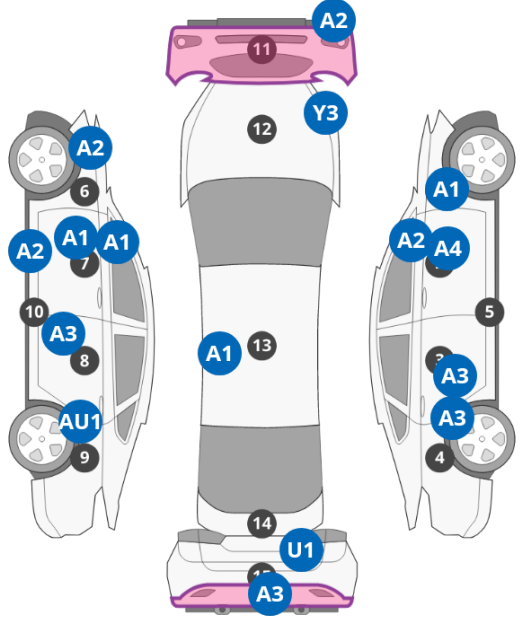
<p>A : Scratch AU : Scratch & Dent B : Modified C : Corrosion G : Stone chip P : Faded S : Rust SC : Rust & Corrosion U : Dent X : Defective Y : Crack, Gap</p>
<p>Remarks (R) Front Seat - Grime - Medium / (L) Front Seat - Worn - Yes / (L) Front Floor Mat - Worked - Small / (R) Front Trim - Grime - Minimal / (L) Front Trim - Grime - Small / Rear Seat - Grime - Small / (R) Front Floor Mat - Grime - Small / Ceiling - Grime - Minimal</p>	<p>Remarks (R) Front Door - Repair Traces - Yes / (R) Front Fender - Repair Traces - Yes / Bonnet - Repair Traces - Yes / (L) Front Fender - Repair Traces - Yes / (L) Front Door - Repair Traces - Yes / (L) Rear Fender - Repair Traces - Yes / Trunk Hood, Rear Gate - Repair Traces - Yes / (R) Rear Fender - Repair Traces - Yes / Roof - Repair Traces - Yes / (R) Mirror - Scratch - Small / (R) Front Fender, Molding - Scratch - Minimal / (R) Front Door, Molding - Scratch - Large / (R) Rear Door, Molding - Scratch - Medium / (R) Rear Fender, Molding - Scratch - Medium / Overall Exterior - Full Re-Paint in same color - Yes / Rear Bumper, Lamps, Panels - Repair mark - Yes / Rear Bumper, Lamps, Panels - Scratch - Medium / (L) Rear Fender, Molding - Scratch & Dent - Minimal / (L) Step, In-panel, Side Spoiler - Scratch - Small / (L) Rear Door, Molding - Scratch - Medium / (L) Front Door, Molding - Scratch - Minimal / (L) Mirror - Scratch - Minimal / (L) Front Fender, Molding - Scratch - Small / Front Bumper, Grille, Lamps - Scratch - Small / Bonnet, Headlight - Crack, Gap - Medium / Front Bumper, Grille, Lamps - Repair mark - Yes / Roof - Scratch - Minimal / Trunk Hood, Rear Gate - Dent - Minimal</p>
