General Information

Make	Toyota	Model	Vios
YOM	2026	Odo Meter Reading	4,843
Registration No.	NJK3830	Chassis No.	PA1B18F31S4297446
CC	1.3	Transmission	CVT
Fuel Type	Gas	Type of Body	Sedan
Colour	Red

Body / Panel Condition

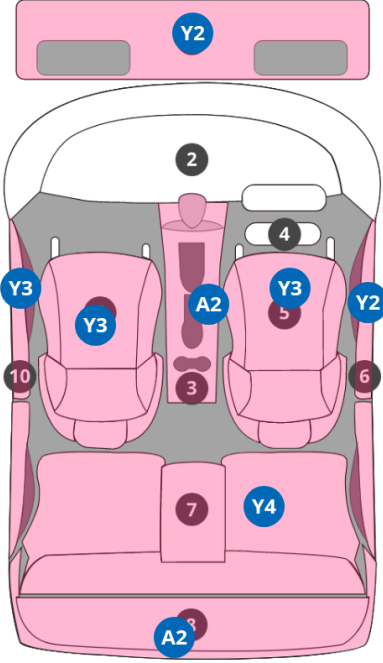
Interior Evaluation : C	Exterior Evaluation : E

<p>a : Cut, Fray d : Loose, Deformed k : Animal Hair s : Smell t : Cigarette Burns x : Defective y : Stain</p>

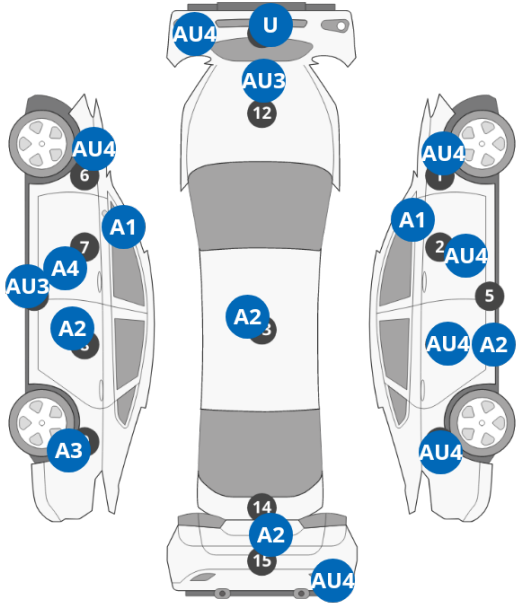
<p>A : Scratch AU : Scratch & Dent B : Modified C : Corrosion G : Stone chip P : Faded S : Rust SC : Rust & Corrosion U : Dent X : Defective Y : Crack, Gap</p>
<p>Remarks (R) Front Seat - Grime - Medium / (R) Front Trim - Grime - Small / Rear Seat - Grime - Large / Trunk Room - Worn, Scratch, Cut, Crack - Small / (L) Front Trim - Grime - Medium / (L) Front Seat - Grime - Medium / Ceiling - Grime - Small / Console, Switches, Vents - Worn, Scratch, Cut, Crack - Small</p>	<p>Remarks (L) Front Fender, Molding - Scratch & Dent - Large / Front Bumper, Grille, Lamps - Scratch & Dent - Large / (R) Mirror - Scratch - Minimal / (R) Front Door, Molding - Scratch & Dent - Large / (R) Rear Door, Molding - Scratch & Dent - Large / (R) Step, In-panel, Side Spoiler - Scratch - Small / (R) Rear Fender, Molding - Scratch & Dent - Large / Rear Bumper, Lamps, Panels - Scratch & Dent - Large / Trunk Hood, Rear Gate - Scratch - Small / (L) Rear Fender, Molding - Scratch - Medium / (L) Rear Door, Molding - Scratch - Small / (L) Front Door, Molding - Scratch - Large / Bonnet, Headlight - Scratch & Dent - Medium / (R) Front Fender, Molding - Scratch & Dent - Large / (L) Step, In-panel, Side Spoiler - Scratch & Dent - Medium / Roof - Scratch - Small / (L) Mirror - Scratch - Minimal / Member (Bolted) - Dent - Yes</p>

<p>Inspector Notes</p>
<p>with LTO plate/with spare tire/No spare key/with jack No tools/No seat cover/No warranty booklet/with reverse camera/front bumper traces of bent</p>
