General Information

Make	Toyota	Model	Hilux Tamaraw
YOM	2025	Odo Meter Reading	15,900
Registration No.	NKS4910	Chassis No.	PAHACACA3S6424705
CC	2.4	Transmission	M/T
Fuel Type	Diesel	Type of Body	Utility Passenger
Colour	White

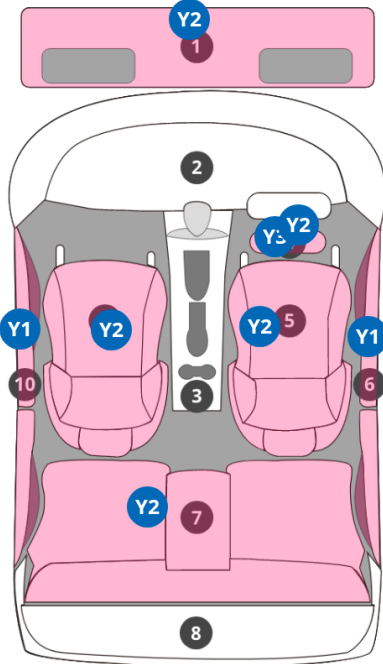
Interior Evaluation : B	Exterior Evaluation : E

<p>A : Scratch AU : Scratch & Dent B : Modified C : Corrosion G : Stone chip P : Faded S : Rust SC : Rust & Corrosion U : Dent X : Defective Y : Crack, Gap</p>
<p>Remarks (L) Front Seat - Grime - Small / (R) Front Seat - Grime - Small / (L) Front Floor Mat - Grime - Medium / Rear Seat - Grime - Small / (L) Front Trim - Grime - Minimal / (R) Front Trim - Grime - Minimal / Ceiling - Grime - Small / (R) Front Floor Mat - Grime - Small</p>	<p>Remarks (L) Front Door, Molding - Scratch & Dent - Small / (L) Front Fender, Molding - Scratch & Dent - Small / Bonnet, Headlight - Scratch & Dent - Small / Front Bumper, Grille, Lamps - Scratch - Small / (R) Front Fender, Molding - Scratch & Dent - Small / (R) Front Door, Molding - Scratch & Dent - Small / Roof - Dent - Medium / Cargo Bed Floor - Scratch & Dent - Medium / (L) Side Gate - Scratch & Dent - Small / Rear Gate - Scratch & Dent - Small / Rear Bumper, Lamps, Panels - Scratch - Small / (R) Side Gate - Scratch & Dent - Small / (R) Step, In-panel, Side Spoiler - Scratch & Dent - Small / (L) Step, In-panel, Side Spoiler - Scratch & Dent - Small / Front Windshield - Damaged - Large</p>

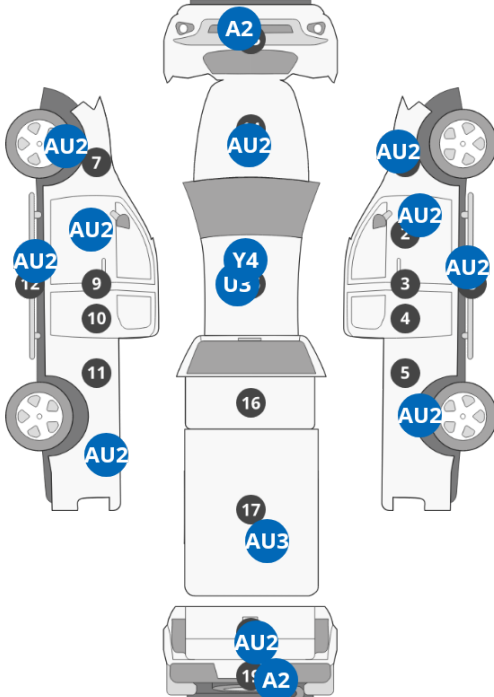
<p>Inspector Notes</p>
<p>No LTO plate, with spare tire, with spare key, with jack, no tools, with manual and warranty booklet, scratches on taillight and headlight, issue on windshield.</p>
