General Information

Make	Toyota	Model	Rush
YOM	2021	Odo Meter Reading	37,222
Registration No.	NGL6044	Chassis No.	MHKE8FF3PMK031903
CC	1.5	Transmission	A/T
Fuel Type	Gas	Type of Body	SUV
Colour	Silver

Body / Panel Condition

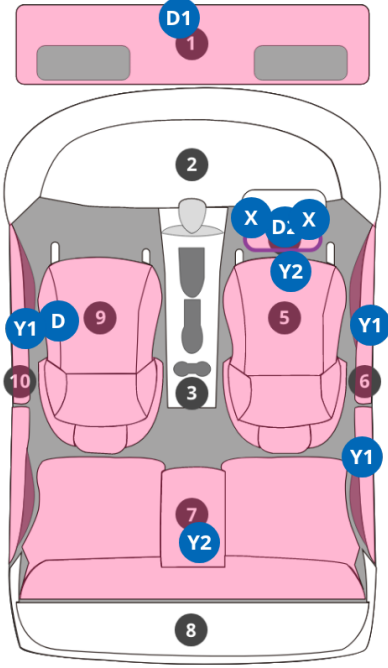
Interior Evaluation : B	Exterior Evaluation : E

<p>a : Cut, Fray d : Loose, Deformed k : Animal Hair s : Smell t : Cigarette Burns x : Defective y : Stain</p>

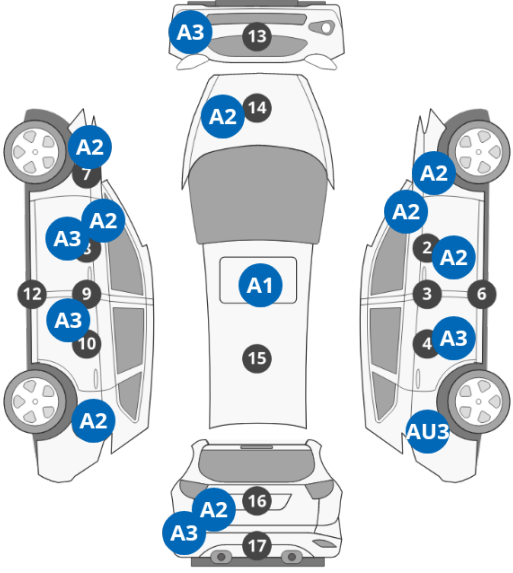
<p>A : Scratch AU : Scratch & Dent B : Modified C : Corrosion G : Stone chip P : Faded S : Rust SC : Rust & Corrosion U : Dent X : Defective Y : Crack, Gap</p>
<p>Remarks (L) Front Seat - Worn - Yes / (R) Front Seat - Grime - Small / Mat Other - Worked - Small / (L) Front Floor Mat - Missing - Yes / (R) Front Floor Mat - Missing - Yes / (L) Front Trim - Grime - Minimal / (R) Front Trim - Grime - Minimal / (R) Rear Trim - Grime - Minimal / Rear Seat - Grime - Small / Ceiling - Crinkle - Minimal</p>	<p>Remarks (R) Mirror - Scratch - Small / (R) Front Fender, Molding - Scratch - Small / (R) Front Door, Molding - Scratch - Small / (R) Rear Door, Molding - Scratch - Medium / (R) Rear Fender, Molding - Scratch & Dent - Medium / Rear Bumper, Lamps, Panels - Scratch - Medium / Trunk Hood, Rear Gate - Scratch - Small / (L) Rear Fender, Molding - Scratch - Small / (L) Mirror - Scratch - Small / (L) Front Fender, Molding - Scratch - Small / Front Bumper, Grille, Lamps - Scratch - Medium / Bonnet, Headlight - Scratch - Small / (L) Rear Door, Molding - Scratch - Medium / (L) Front Door, Molding - Scratch - Medium / Roof - Scratch - Minimal</p>
