General Information

Make	Toyota	Model	Vios
YOM	2023	Odo Meter Reading	36,137
Registration No.	NEY1780	Chassis No.	PA1B18F34P4216351
CC	1.3	Transmission	CVT
Fuel Type	Gas	Type of Body	Sedan
Colour	Blue

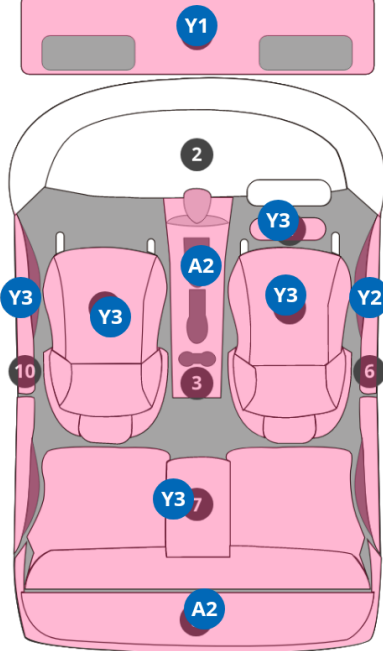
Interior Evaluation : C	Exterior Evaluation : D

<p>a : Cut, Fray d : Loose, Deformed k : Animal Hair s : Smell t : Cigarette Burns x : Defective y : Stain</p>

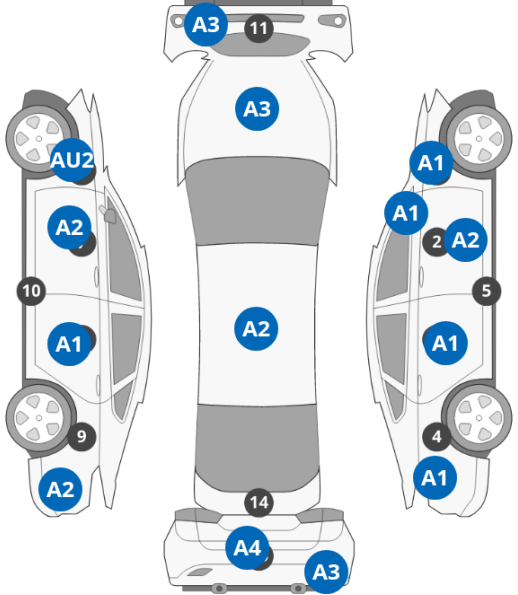
<p>A : Scratch AU : Scratch & Dent B : Modified C : Corrosion G : Stone chip P : Faded S : Rust SC : Rust & Corrosion U : Dent X : Defective Y : Crack, Gap</p>
Remarks (R) Front Seat - Grime - Medium / (R) Front Trim - Grime - Small / Rear Seat - Grime - Medium / Trunk Room - Worn, Scratch, Cut, Crack - Small / (L) Front Trim - Grime - Medium / (L) Front Floor Mat - Grime - Medium / (L) Front Seat - Grime - Medium / Ceiling - Grime - Minimal / Console, Switchs, Vents - Worn, Scratch, Cut, Crack - Small	Remarks Roof - Scratch - Small / (L) Front Door, Molding - Scratch - Small / (L) Rear Door, Molding - Scratch - Minimal / (L) Front Fender, Molding - Scratch & Dent - Small / Bonnet, Headlight - Scratch - Medium / Front Bumper, Grille, Lamps - Scratch - Medium / (R) Mirror - Scratch - Minimal / (R) Front Fender, Molding - Scratch - Minimal / (R) Front Door, Molding - Scratch - Small / Trunk Hood, Rear Gate - Scratch - Large / Rear Bumper, Lamps, Panels - Scratch - Medium / (L) Rear Fender, Molding - Scratch - Small / (R) Rear Fender, Molding - Scratch - Minimal / (R) Rear Door, Molding - Scratch - Minimal
