## General Information

| Make | Toyota | Model | Vios |
| Registration No. | NHA3184 | Chassis No. | PA1B18F35L4130699 |

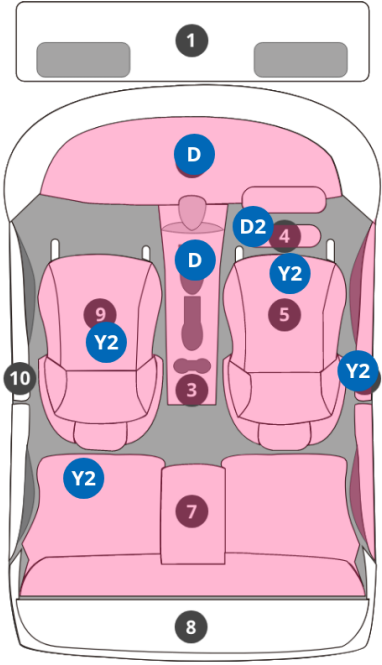
| Interior Evaluation : <b>B</b> | Exterior Evaluation : <b>C</b> |
| <b>Remarks</b><br>(R) Front Trim - Grime - Small / Dashboard - Traces of Adhesive Tape - Yes / Console, Switches, Vents - Traces of Adhesive Tape - Yes / (R) Front Seat - Grime - Small / Rear Seat - Grime - Small / (L) Front Floor Mat - Worked - Small / (L) Front Seat - Grime - Small | <b>Remarks</b><br>Bonnet - Repair Traces - Yes / (L) Rear Fender - Repair Traces - Yes / Roof - Repair Traces - Yes / (L) Front Door, Molding - Scratch & Dent - Minimal / (L) Rear Fender, Molding - Scratch & Dent - Small / (L) Rear Door, Molding - Scratch - Medium / (R) Front Door, Molding - Scratch - Small / Rear Bumper, Lamps, Panels - Scratch & Dent - Large / Trunk Hood, Rear Gate - Scratch & Dent - Minimal / Front Bumper, Grille, Lamps - Scratch - Medium |
