General Information

Make	Toyota	Model	Vios
YOM	2022	Odo Meter Reading	56,011
Registration No.	FAJ7794	Chassis No.	PA1B18F36N4179428
CC	1.3	Transmission	CVT
Fuel Type	Gas	Type of Body	Sedan
Colour	Red

Body / Panel Condition

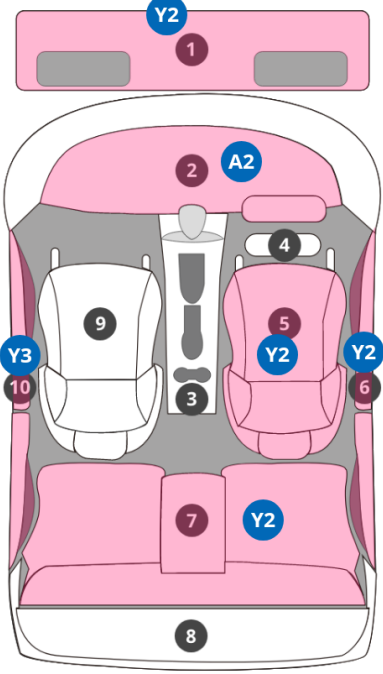
Interior Evaluation : B	Exterior Evaluation : C

<p>a : Cut, Fray d : Loose, Deformed k : Animal Hair s : Smell t : Cigarette Burns x : Defective y : Stain</p>

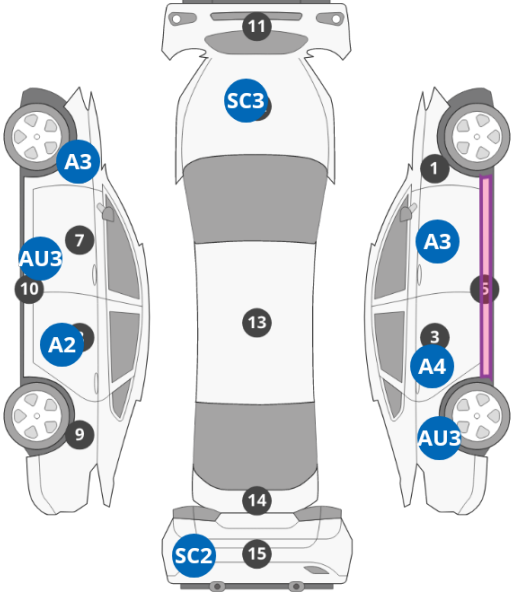
<p>A : Scratch AU : Scratch & Dent B : Modified C : Corrosion G : Stone chip P : Faded S : Rust SC : Rust & Corrosion U : Dent X : Defective Y : Crack, Gap</p>
<p>Remarks (L) Front Trim - Grime - Medium / (R) Front Trim - Grime - Small / Dashboard - Worn, Scratch, Cut, Crack - Small / Ceiling - Grime - Small / (R) Front Seat - Grime - Small / Rear Seat - Grime - Small</p>	<p>Remarks (R) Step - Repair Traces - Yes / (R) Step - Replaced - Yes / (R) Front Door, Molding - Scratch - Medium / (R) Rear Door, Molding - Scratch - Large / (R) Rear Fender, Molding - Scratch & Dent - Medium / Rear Bumper, Lamps, Panels - Rust, Corrosion - Small / (L) Rear Door, Molding - Scratch - Small / (L) Front Door, Molding - Scratch & Dent - Medium / (L) Front Fender, Molding - Scratch - Medium / Bonnet, Headlight - Rust, Corrosion - Medium</p>
